CONCRETE REPAIR

Concrete Repair / Rehabilitation
 Quick Mender® X.O. Repair Polymer
 Cold Storage Freezer, Dallas, TX
 Private
 Exposed Floors, Garland, TX

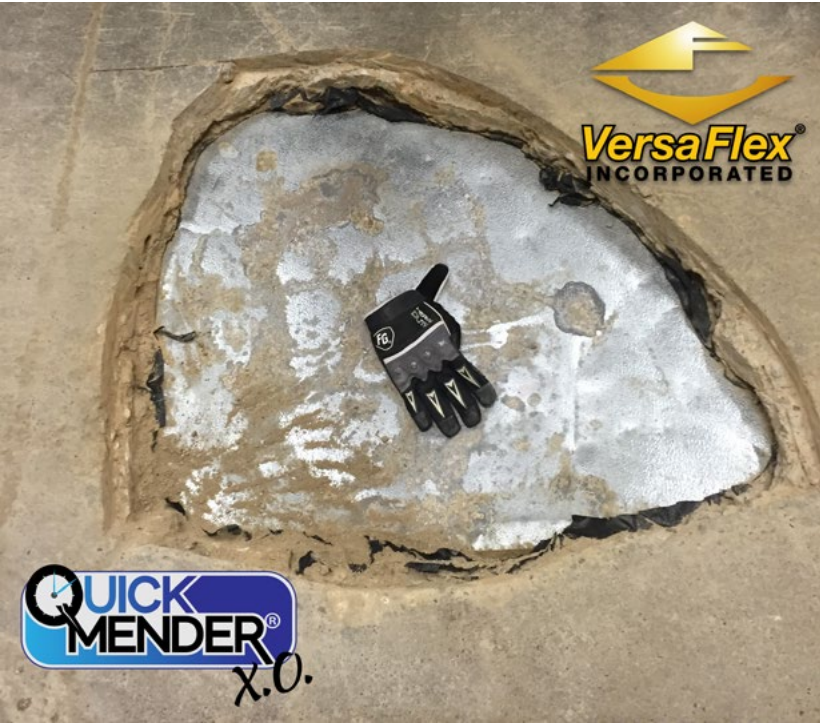
In a cold storage facility in Dallas, TX, this scenario became a reality. Two large crater-like holes were beginning to form and the concrete was crumbling badly. The crater-like holes had grown to sizes of about 5 ft. by 3 ft. and 2 ft. by 3 ft. at a depth of about 5 inches each, meaning it was no longer safe to drive forklifts in the area, causing traffic to be re-routed to other areas of the warehouse. The facility owner decided to get it repaired quickly, and called Steve Cassity of Exposed Floors of Garland, TX to help.

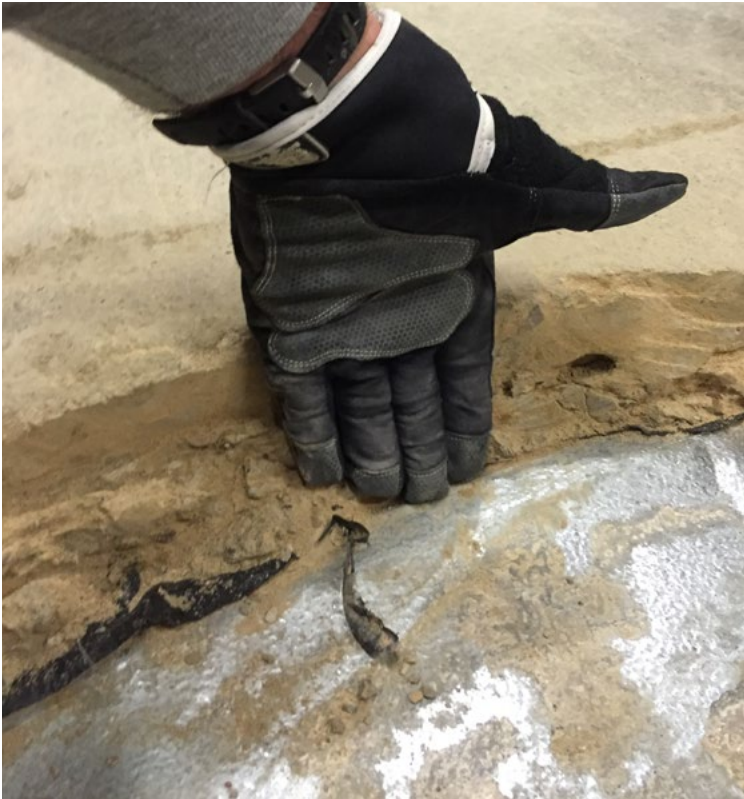
remove all of the crumbled concrete to approximately 5" deep where they found, at the bottom of the crater-like hole, an insulated panel that was covered with a metal plate and plastic sheeting. The crew then proceeded to remove all remaining rubble and debris and proceeded with repairs.

The original plans called for concrete rebar to be inserted into the surrounding concrete in order to provide support, but when the Exposed Floor crew tried to drill holes for the rebar, the concrete crumbled. So, the crew proceeded with "Plan B", which was to re-cover the metal plate at the bottom with 15 mils of plastic sheeting and continue with repairs. Next the crew used a 110v concrete saw to cut around area to create a clean edge for the repair.
