CONCRETE RESTORATION

Concrete Restoration / Rehabilitation

Bill Graham Civic Auditorium, San Francisco, California

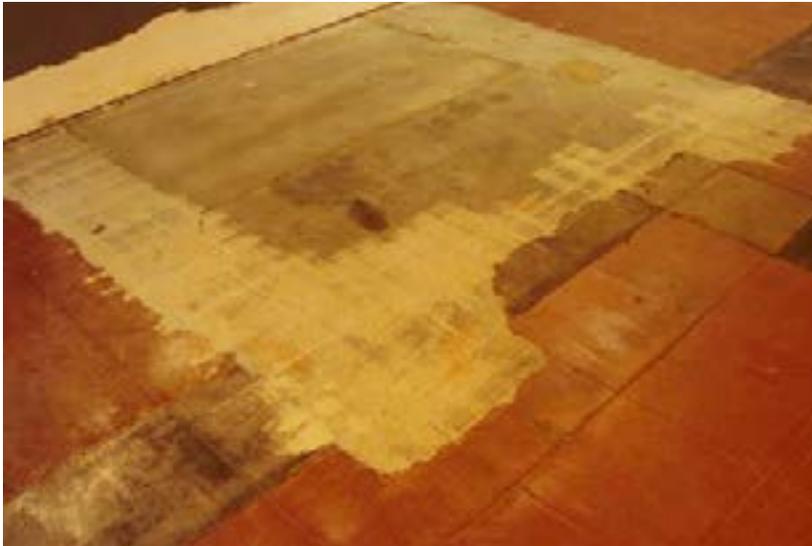
Previous repair attempts found beneath carpeting

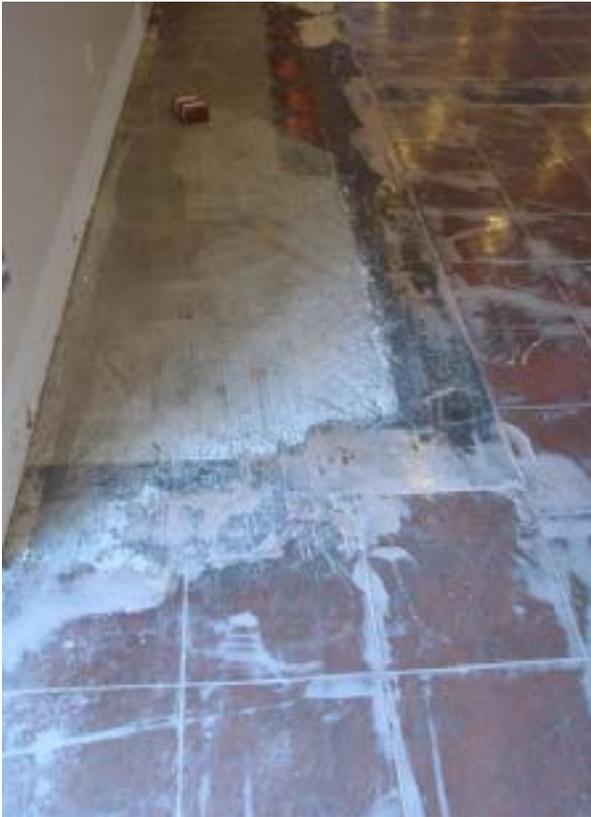
Some initial patchwork
