POND LINER & WATER FEATURE

Pond Liners & Water Features

SL/75 : Low Pressure Spray Polyurea; Quick Mender® Primer

Installation of Koi Pond Liner

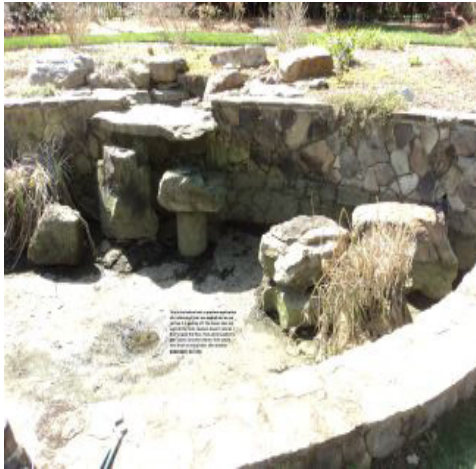
The existing pond was very dirty which required a controlled pressure wash cleaning to remove the contaminants and dirt.

Next, the failed existing liner was removed from the substrate utilizing a cup wire grinding wheel. A diamond grinding disk scored the surface and provided the profile for the new coating. VersaFlex Quick Mender® was applied as a primer mixed with sand to seal the repaired areas. The finish coat consisted of spraying 125mils of VersaFlex SL/75 on the floor and 100mils on the basin walls using an AST GMP-050 spray pump.

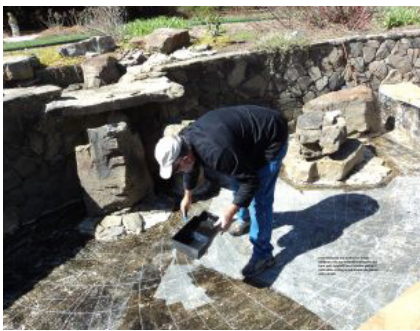
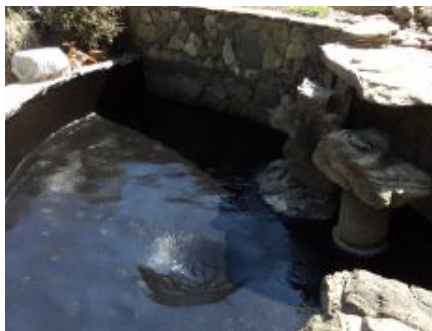
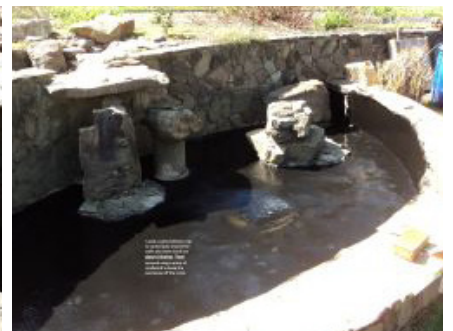
Koi Pond during and after installation of SL/75 using low-pressure spray equipment
