FLOOR COATINGS

MARKET SYSTEM PROJECT

Floor Coatings : Refurbishing / Sealing
 SL/75 Sealant, Quick Mender® Concrete Repair System
 Kitchen Floor Rehabilitation
 Private : Atria Management
 B & H Coatings, Hebron, MD

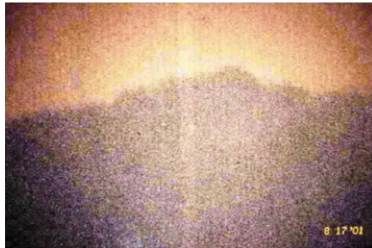
After several years using an epoxy coated floor in the commercial kitchen area, Atria Salisbury management decided that the floor had been used past its service life. The replacement of the floor using epoxy would require a kitchen shutdown of several days, which was not satisfactory to the Owner.

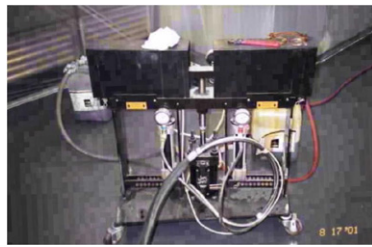
B & H Coatings was consulted about alternative solutions for floor coating replacement. The requirements were discussed and a need for speed of installation and return to service as well as the installation of an easily cleanable surface was determined to be paramount. B & H recommended using VersaFlex pure polyurea as the proposed floor coating product.
