**MARKET SYSTEM PROJECT**

Potable Water : Water Tanks  
 VF 20 Primer, AquaVers® 405 Pure Polyurea  
 Redstone Arsenal Water Tank Rehab; 5,000,000 gallons  
 Redstone Arsenal Base, Huntsville, Alabama  
 Contracting and Materials, Decatur, Alabama

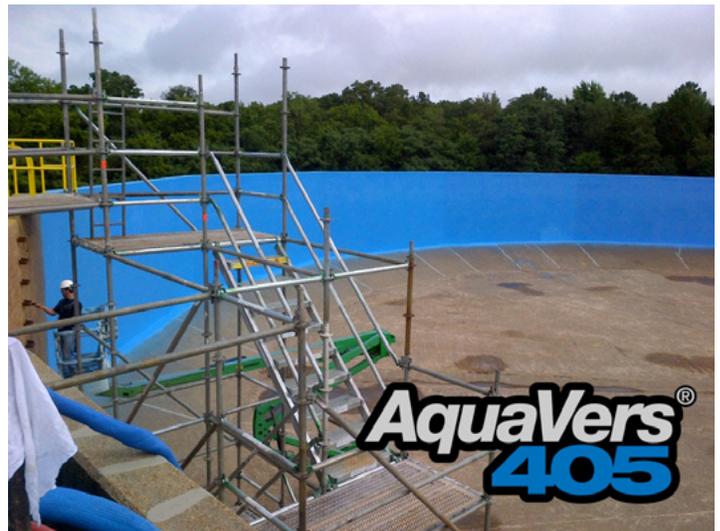
The first step in a 3 week preparation

process was to drain and clean the tank. C&M used a combination of a 24,000 psi pressure washer and standard 4,000 psi pressure washer on the walls and floor. After cleaning the tank, they set up scaffolding so work could be monitored at all times.

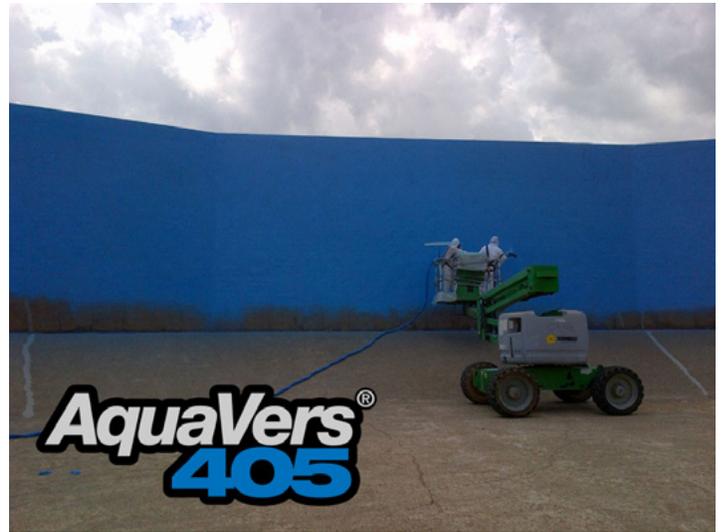
The scaffolding also became their work platform for their spray equipment, daily product storage, tank access and control center. All cracks over 1/8" wide were repaired with a concrete repair grout. The concrete surfaces were primed with VersaFlex VF 20 primer, and 80-100 mils of AquaVers 405 was applied. The walls were completed first. Next they removed the heavy equipment from the floor. The tank base was re-cleaned and primed before the final application of the AquaVers 405 was applied to the floor.
