MARKET SYSTEM PROJECT

Roofing Systems : Over Single Ply EPDM

Roof Coating to Repair Failing Single-Ply EPDM

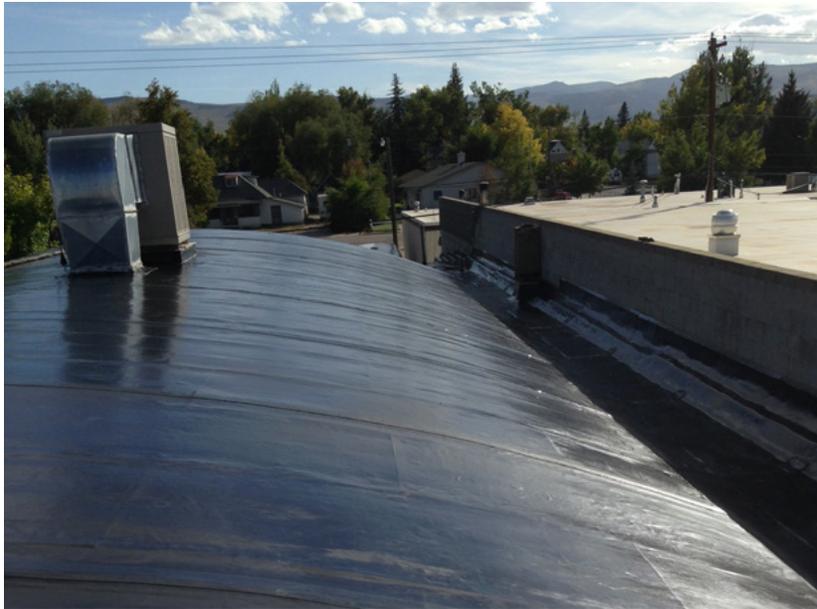
The customer, a commercial retailer in Wyoming, had a single-ply roof membrane with numerous cracks and seam separation, causing water to enter building.

Phat Foam Insulation was hired to repair the roof by applying VersaFlex VF 380 Pure Polyurea.

After inspection of the roof, a plan was made to prep the surface. Areas of concern that had major cracks would be covered with butyl tape to help prevent as much water as possible from

entering the building during the cleaning process. While this was being done, Phat Foam was also blowing and sweeping away any loose dirt, leaves, and other accumulated debris.

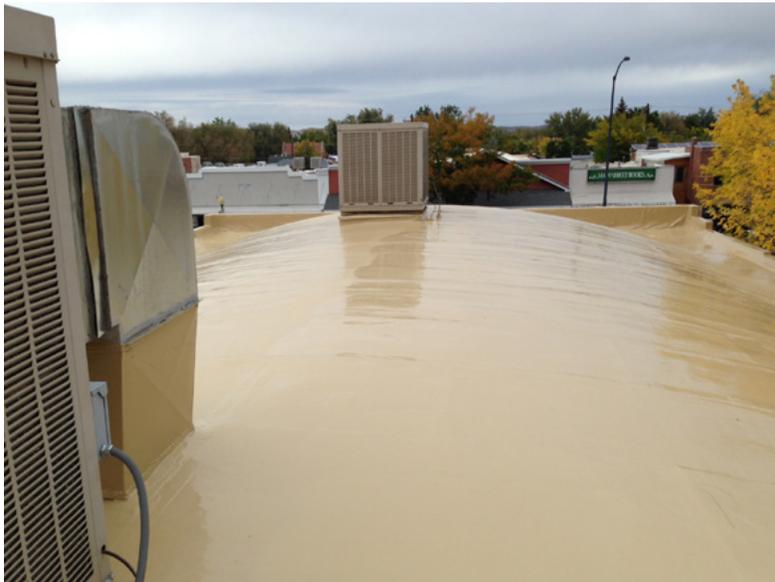
About 30 minutes after completion a heavy rain storm came through and

gave this roof the real test.

The next day, the customer was very happy; it had rained throughout the night and there were no leaks inside his building.
