BETTER MOUSETRAPS: POLYUREA
COATING SEALS TANKS & RESERVOIRS

REHABBING AGING RESERVOIRS AND TANKS

Advanced polyurea coatings and liners provide strong, flexible waterproofing capable of bridging large cracks

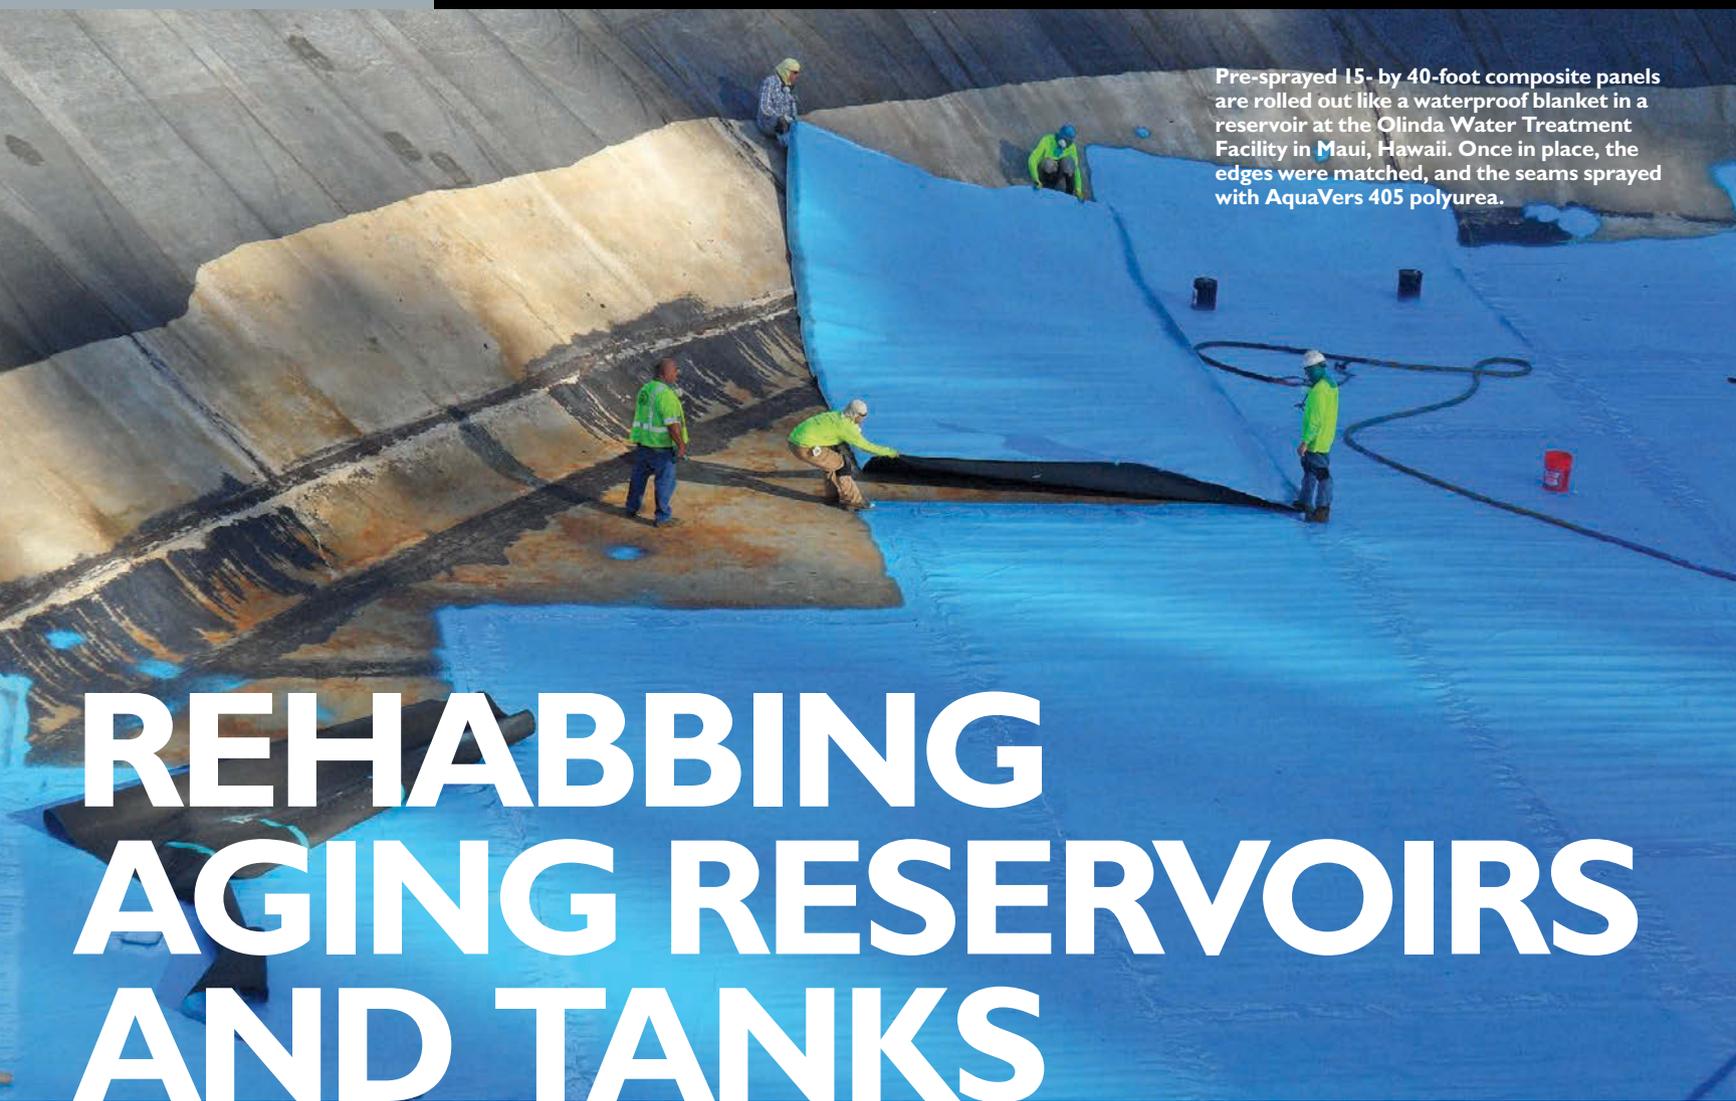
Pre-sprayed 15- by 40-foot composite panels are rolled out like a waterproof blanket in a reservoir at the Olinda Water Treatment Facility in Maui, Hawaii. Once in place, the edges were matched, and the seams sprayed with AquaVers 405 polyurea.

In some cases, polyurea can also be pre-sprayed onto geotextile fabric panels that are placed above the existing substrate. The panels mitigate the need for surface or crack repairs. Once in place, panel edges are then fused together with more polyurea.

After considering all the options, the utility hired restoration contractor Ahbe & Svoboda to install a pre-sprayed composite panel system combining geotextile and a pure polyurea membrane from VersaFlex.

After removing existing reservoir piping and the synthetic rubber liner from the structure's floor, a six-man crew installed AquaVers 405 pre-sprayed geotextile at 80 mils to the interior of the reservoir walls up over its rock parapet.

The pre-sprayed, 15-by-40-foot composite panels rolled out like a waterproof blanket. Once rolled out, the edges were matched, and the seams sprayed with AquaVers 405 pure polyurea. The crew mechanically fastened the geotextile to the reservoir walls with stainless steel termination bars, and then sprayed over the bars. They also sprayed the polyurea on stairs, sumps and penetrations, and tied them to the geotextile.

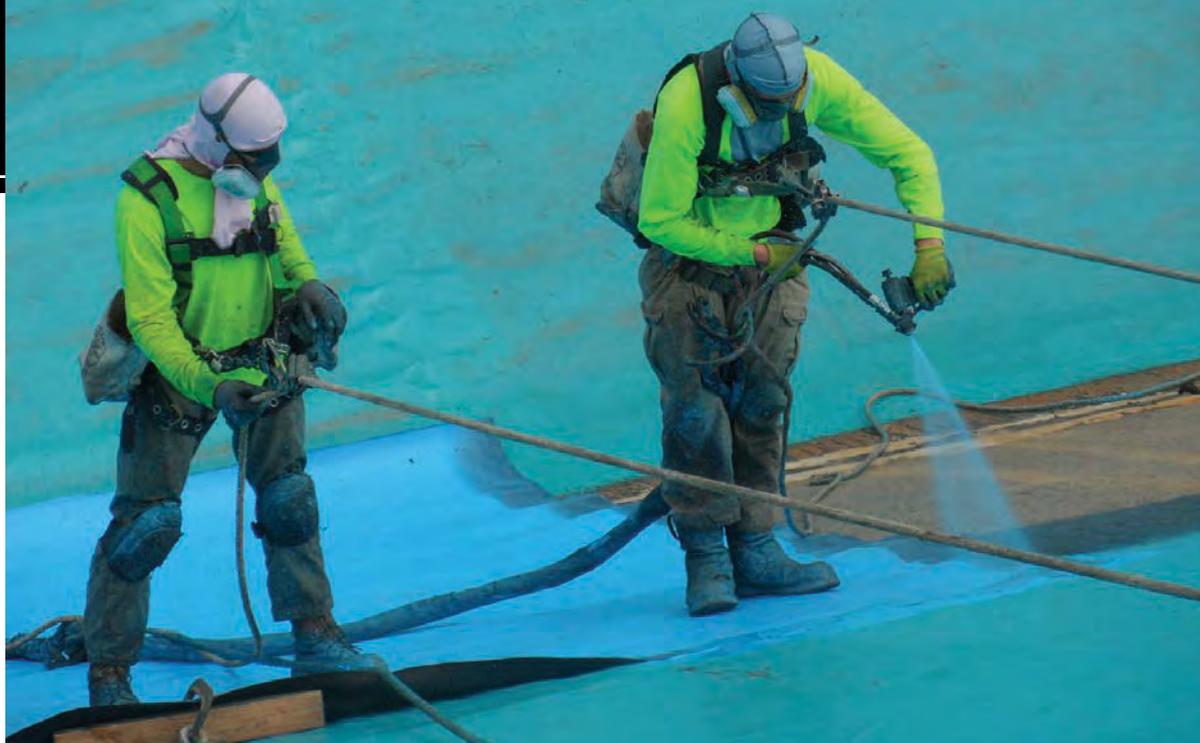
The contractor's crew sprayed polyurea on all stairs, sumps and penetrations at the reservoir, and then tied those to the geotextile.
