'Reshaping' Processing Plants to Reduce Risk of Listeria and other Contaminants

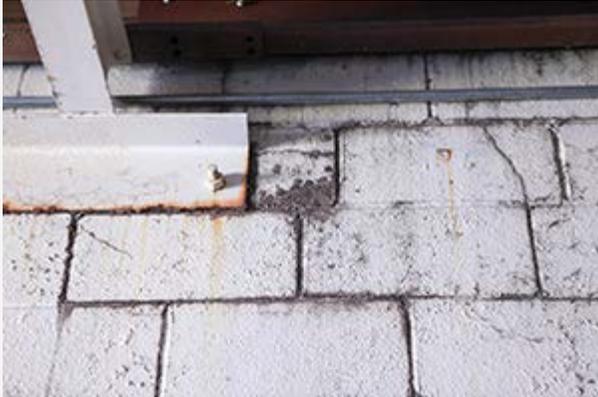
In addition to concerns about bacteria, contamination also comes from facility maintenance issues, such as chipping paint, spalled and cracked concrete, and areas in the walls and ceilings that can collect dust, dirt, mold and other contaminants.

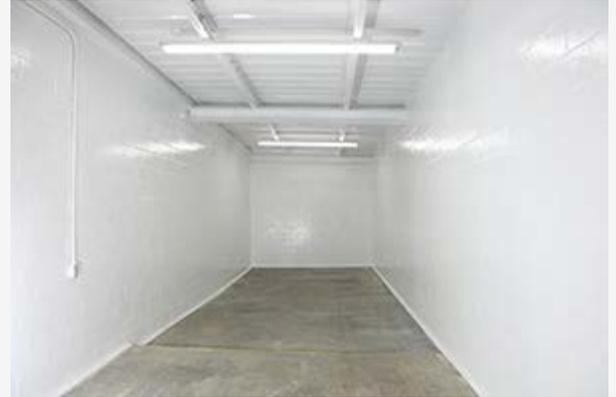
Due to the aggressive nature of plant wash downs, a custom polyurea topcoat is required to complete the process., The final topcoat creates a very slick surface, making it difficult for standing water, dust, dirt, or bacteria to take hold. To complete all this work, Fixxus works with the food facilities to plan and optimally time rehabilitation operations. ,This keeps plant, or area, downtime to a minimum. “These plants typically have only 2 to 4 days to get the work done,” says Cook.
