BIG CHANGES

FOR TEXAS TANKS

To coat the containment system around two new 16,800-gallon (63,594.9 l) tanks at a multi-national pipeline company. The contractor used VF380 to inhibit the H₂S-laden masses from leaching into the ground.

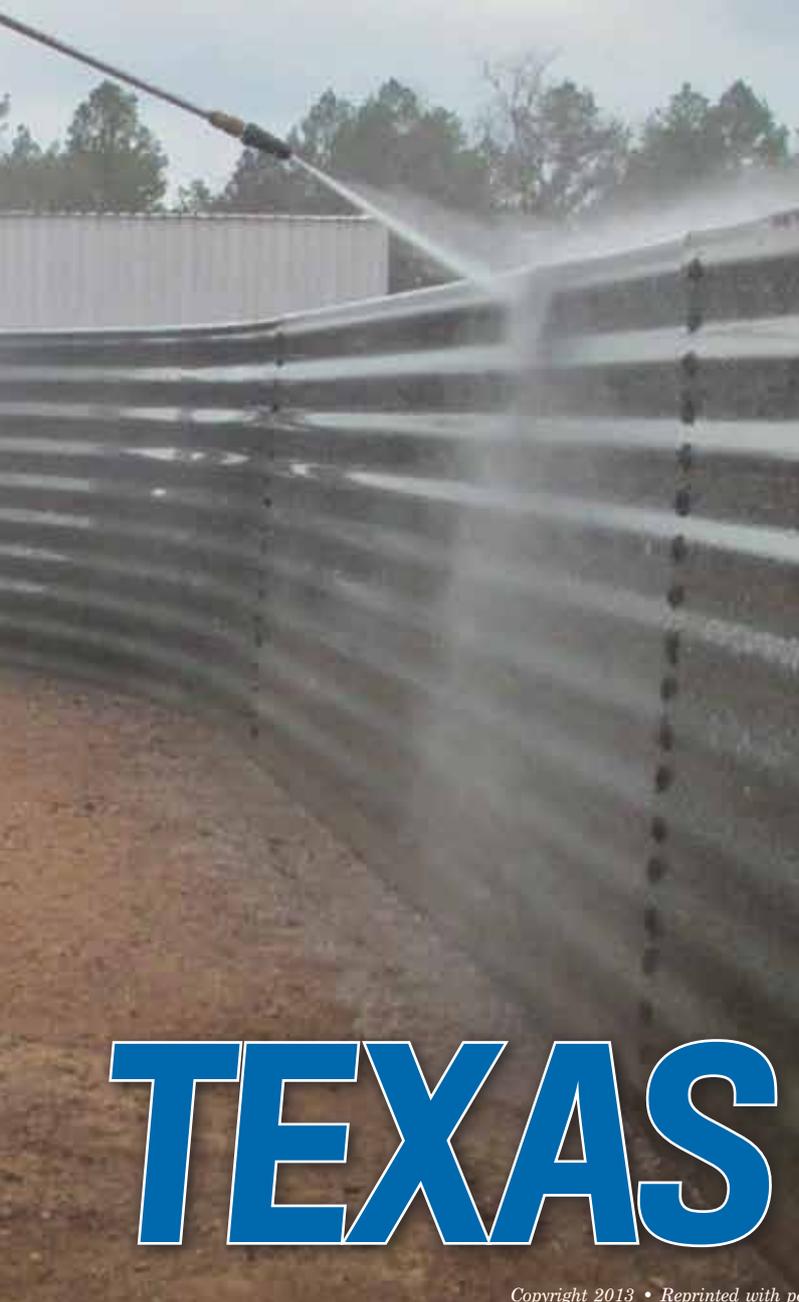
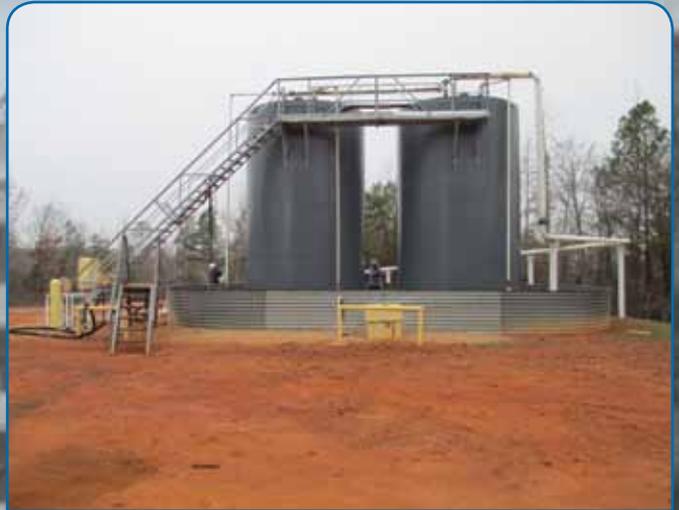
ABOVE ▲ Containment Specialties, Inc. of Louisiana approached the owners of a multi-national pipeline operator in Texas after hearing about issues with a prolonged cure time. They knew just how to create a secondary containment on the 16,800-gallon (63,594.9-L) tanks and save the owners money.

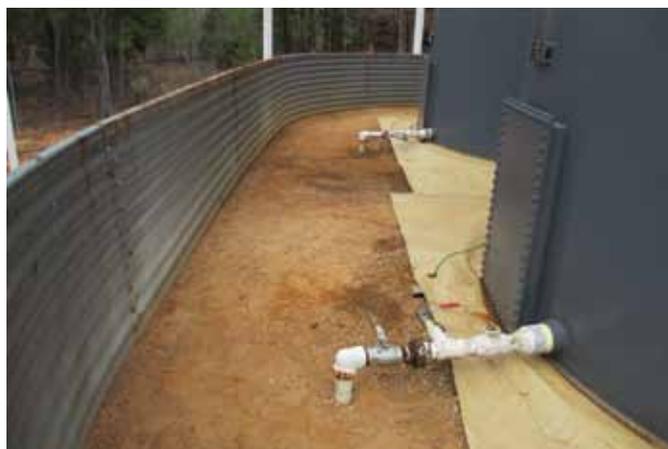
ABOVE ▲ Because the three-foot-tall (0.9 m) steel wall surrounding the tanks was in fair condition, it did not need to be replaced during this round of rehab. The wall, which enclosed the 40'-long by 24'-wide (12.2 m by 7.3 m) area, would help to create the necessary containment.

Once on site, it took the coatings crew two days to complete the rest of their job. They started by pressure-washing the three-foot-tall (0.9 m) wall that was used to enclose the 40'-long by 24'-wide (12.2 m by 7.3 m) containment area. Using a washer at 4,000 pounds per square inch (psi) (27,579 kilopascals) with a zero-degree rotating nozzle, they removed any and all oxidation from the galvanized metal walls. Then they removed large rocks inside the containment and made sure the rings had a bit of a slope away from the tanks. Once everything on the ground

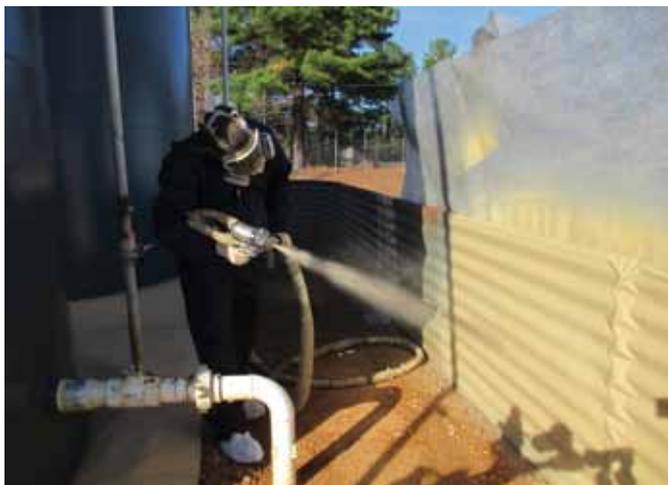
ABOVE ▲ Once all substrates were power-washed to remove any oxidation, the crew came into work on the spray-application of the coatings. Using a Graco H25 proportioner with a 2,300 psi (15,857.9 kPa) compressor, they applied one pass of VF380 at 60 mils (1,524 microns) to the walls and liners.

The next morning, the Containment Specialties crew started on the process to create a monolithic containment. Using a Graco H25 proportioner that generates 2,300 psi (15,857.9 kPa) of fluid pressure, they sprayed the geotextile fabric liner with one 60-mil (1,524-micron) pass of VF380. The material, which uses a plural component, mixed in the chamber of a Fusion Air Purge .01 gun right before hitting the wall and liners.

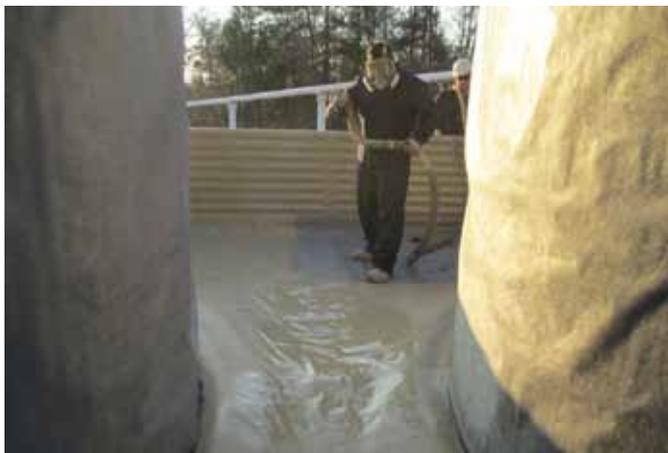
ABOVE ▲ "The cure time on our product is about a 20-second gel time, and in five minutes, you can walk on it," explained Curtis Kennedy III of Containment Specialties. That quick cure time meant that the tanks could return to service in no time at all.

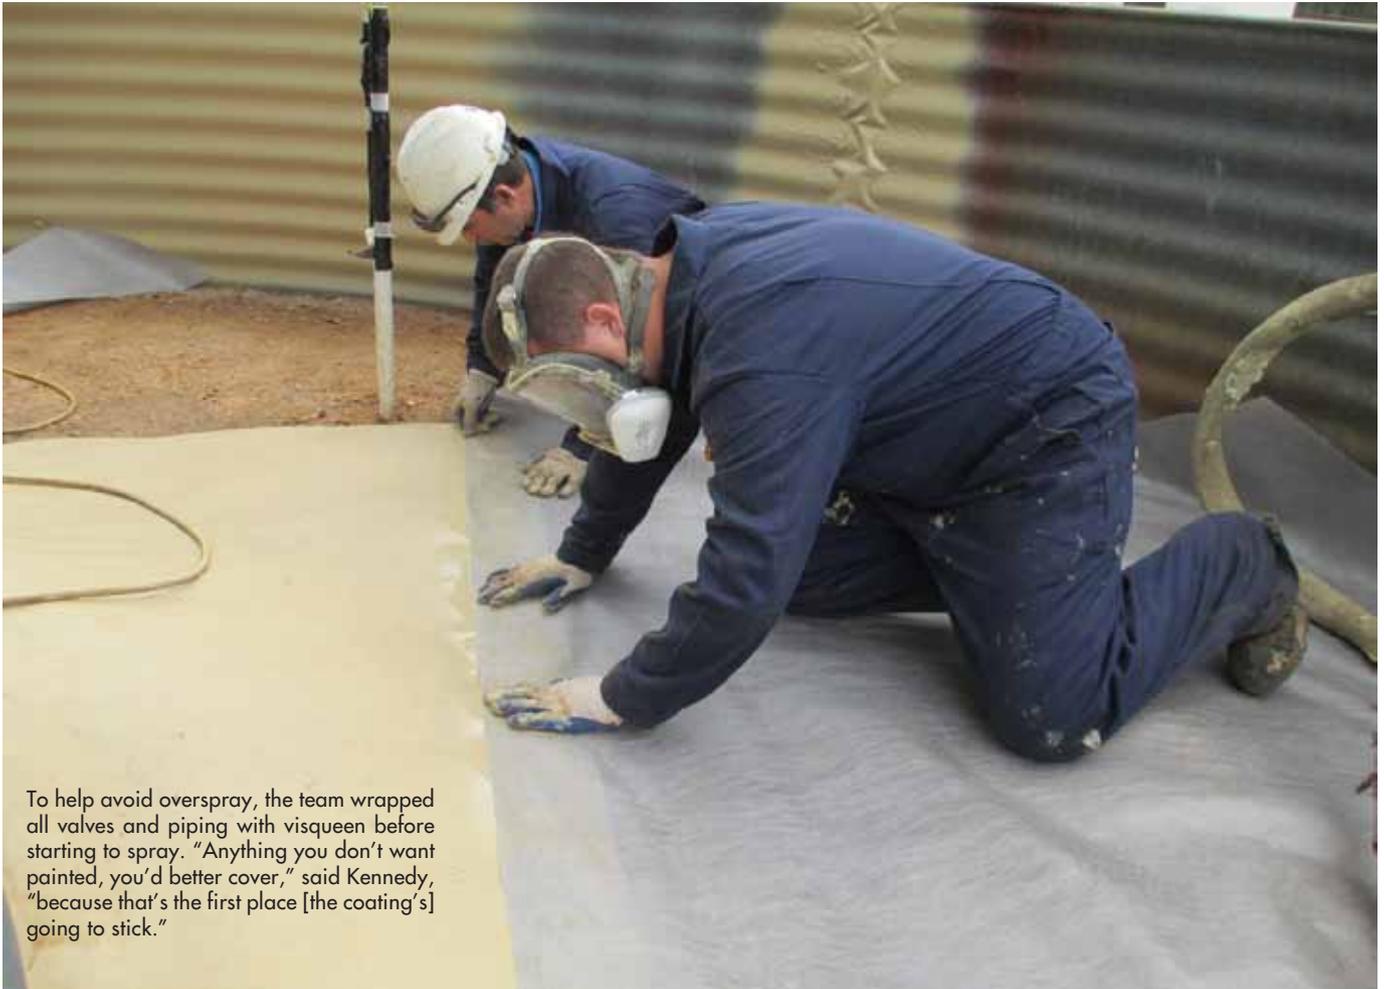
To help avoid overspray, the team wrapped all valves and piping with visqueen before starting to spray. "Anything you don't want painted, you'd better cover," said Kennedy, "because that's the first place [the coating's] going to stick."

"Anything you don't want painted, you'd better cover," said Kennedy, "because that's the first place [the coating's] going to stick." To help avoid overspray, the team wrapped all valves and piping using tape to keep it in place. With the site prepared to spray, the crew headed home for a full night's rest. They knew the second and final day would be a full one.

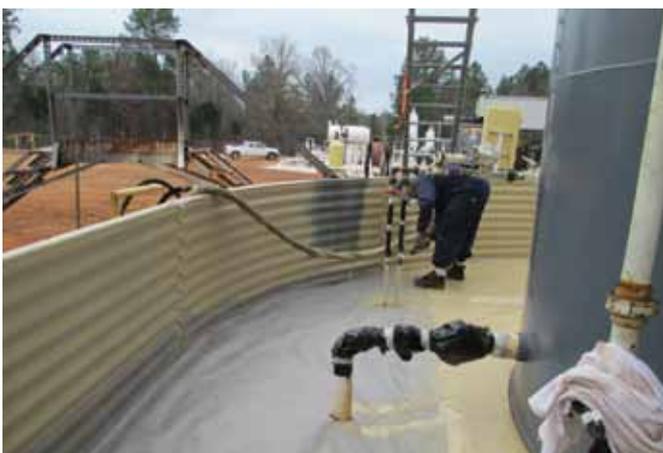
LEFT ◀ Working around natural gas and its by-products meant wearing fire-retardant clothing, hard hats, and safety glasses. All crew members also wore individual H₂S monitors, and the sprayer wore a full-face respirator with organic vapor cartridges from 3M.

gases in case of an emergency, so the location of these stations depended on the way the wind was blowing that day. Find upwind and you'd find that day's muster station! Also, because of the flammable nature of working around natural gas and its byproducts, all crew members wore fire-retardant clothing at all times. They also wore hard hats and safety glasses, and the person spraying wore a full-face respirator with organic vapor cartridges from 3M.

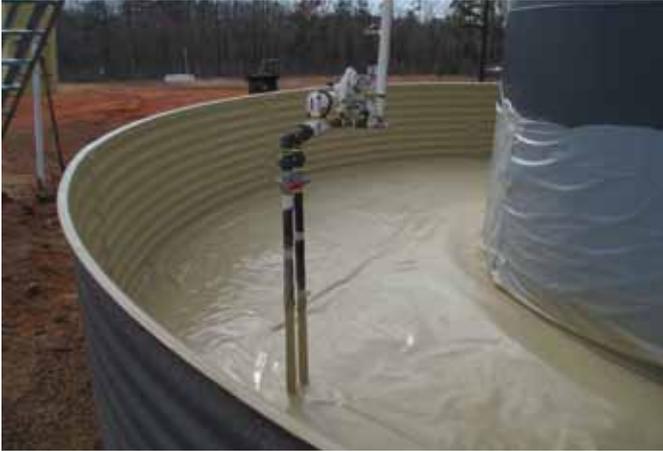
ABOVE ▲ Since setup wasn't too involved on this site, the cleanup stage of the two-day job required basically only one step: Removing any used visqueen. Because the plural components of the coating mixed in the nozzle and not the gun, they didn't even need to clean those.

The 1600-square-foot (148.6 m²) job started and ended quickly. The coatings cured quickly, and the only cleanup required was to remove all of the visqueen from the surfaces. They didn't even need to clean their guns, since the A and B components of the coating mixed in the nozzle and not in the gun. The quick cure and cleanup proved to be crucial to the success of this pipeline company.

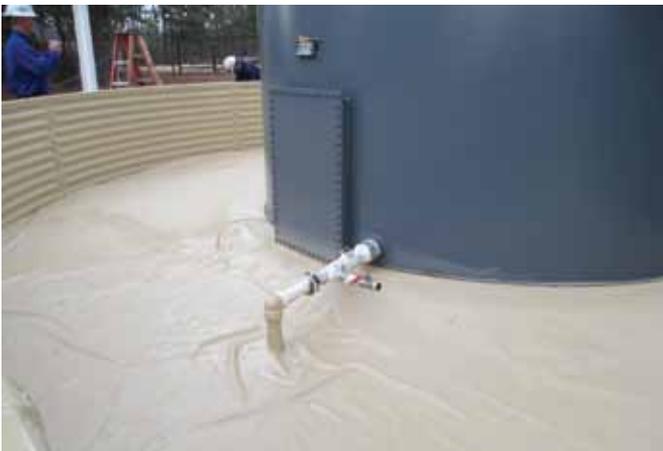
ABOVE ▲ This job acted as a trial run for the tank owners to see how well the Containment Specialties crew and the VersaFlex products worked. If the client approves, as they expect, then the coatings company could be looking at working on all of the company's tanks.
