# Splash

# Rehabbing Aging Concrete Potable Water Reservoirs and Tanks

*Advanced polyurea coatings and liners provide strong, flexible waterproofing to bridge large cracks and protect against future cracking*

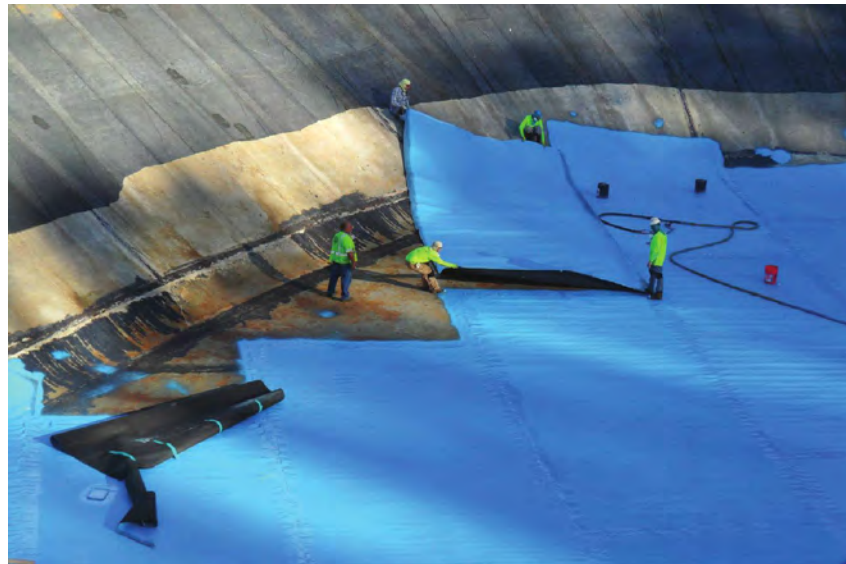
The pre-sprayed, 15'x40', composite panels eased installation by rolling out like a waterproof blanket onsite. Once rolled out, the edges were matched, and the seams sprayed with AquaVers 405 polyurea.

The pre-sprayed, 15'x40', composite panels eased installation by rolling out like a waterproof blanket onsite. Once rolled out, the edges were matched, and the seams sprayed with pure polyurea. The crew mechanically fastened the geotextile to the reservoir walls with stainless termination bars, and then sprayed over the bars. They also sprayed the polyurea on stairs, sumps, and penetrations, and tied these to the geotextile.

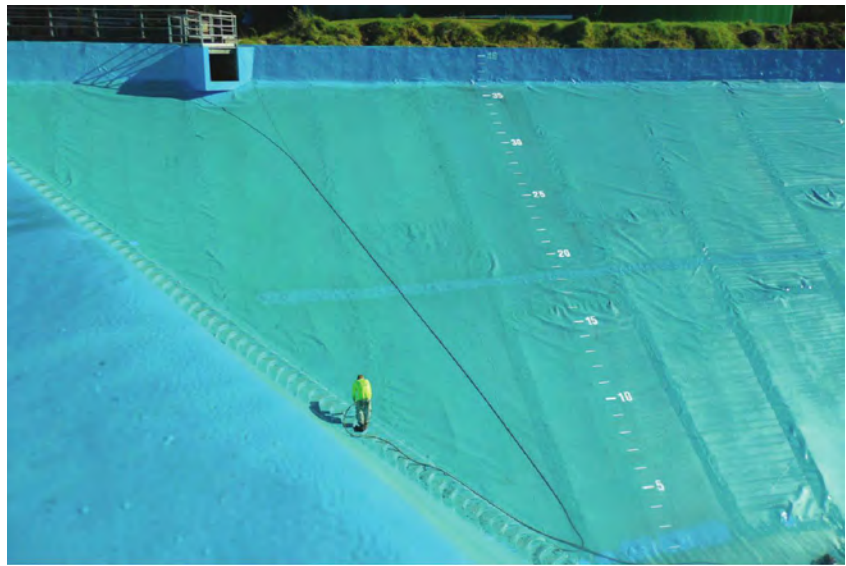
To provide cost-effective, decades-long waterproofing restoration the restoration contractor used pre-sprayed composite panel system combining geotextile and a pure polyurea membrane from VersaFlex.

To provide cost-effective, decades-long waterproofing, a full-service

restoration contractor used a pre-sprayed composite panel system combining geotextile and a pure polyurea membrane.

After removing existing reservoir piping and the synthetic rubber liner from the structure's floor, a six-man crew installed AquaVers 405 pre-sprayed geotextile at 80 mils to the interior of the reservoir walls up over its rock parapet.
