POTABLE
WATER

AquaVers™ 405, FSS 45DC™ Pure Polyurea

Timber Ridge Tank Rehabilitation (500,000 gallons)

Mammoth Community Water District, Mammoth Lakes, California

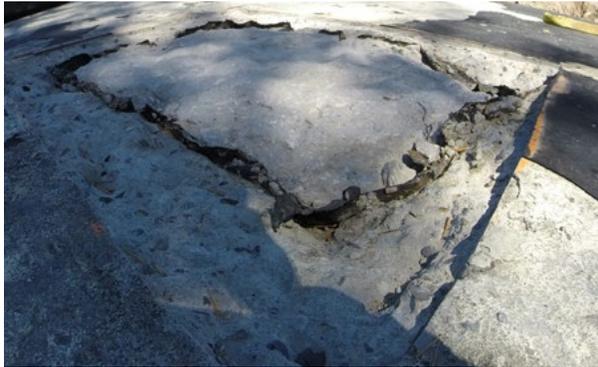
CONCRETE REPAIR

7. Repairing portions of deteriorated concrete.

Once these steps were completed, application of VersaFlex materials could proceed. For the top of the tank, it was necessary to remove the existing coating and repair the degraded areas using a polymer modified cement. Subsequently, fabric was laid out with 6 inch overlaps at all seams. Care was taken to ensure that the geotextile was positioned to conform to the surface irregularities as much as possible. Excessive wrinkles were avoided.

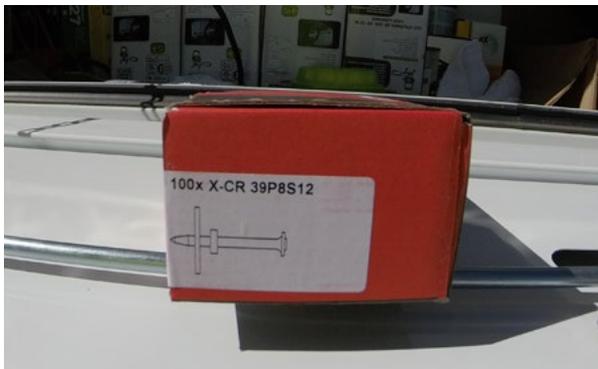
Fabric was fastened to the concrete substrate using Hilti stainless steel powder-actuated fasteners with 2" Stainless Steel washers to fasten horizontal surfaces at all seams at approximately 4-feet on center and a maximum of 5-feet on center in each direction between seams. On vertical surfaces the same power-actuated fasteners with washers were used to fasten all seams at approximately 2-feet on center and a maximum of 3-feet on center in each direction between seams. Terminations were fastened using either powder-actuated fasteners

with washers. Each fastener was spot sprayed before and after install to insure adequate seal. An initial tacking coat of FSS 45DC™ polyurea (in Ryno Gray) at 10-15 mils was used as an adhesive to hold the fabric during placement and fastening, and then was spray coated to a minimum thickness of 80 Mils. High winds during spray application of the lid slowed down the process, and a few extra days were expended waiting for more favorable spray conditions.

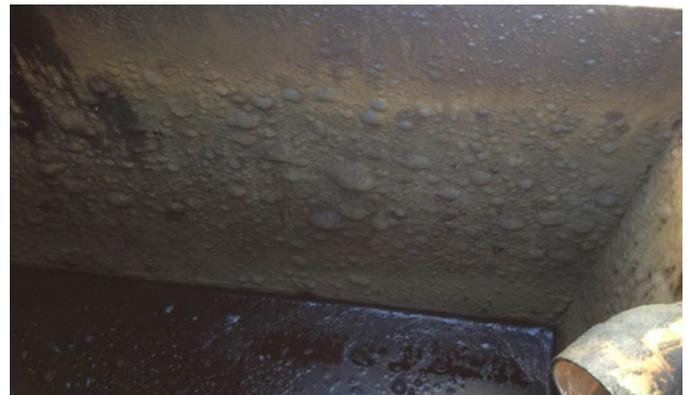
After draining the tank, it was evident that the existing coal tar epoxy was riddled with water-filled blisters. Removing the failing coating added a delay before installing the fabric PUA system. Dehumidification was not necessary because of the dry climate. The same fabric application and spray procedures were adhered to as above. Liner termination was above the water line and direct to the prepared concrete substrate. AquaVers™ 405 polyurea

Existing Coal Tar Epoxy Coating

was sprayed to a minimum of 80 mils on the interior, over the applied fabric.

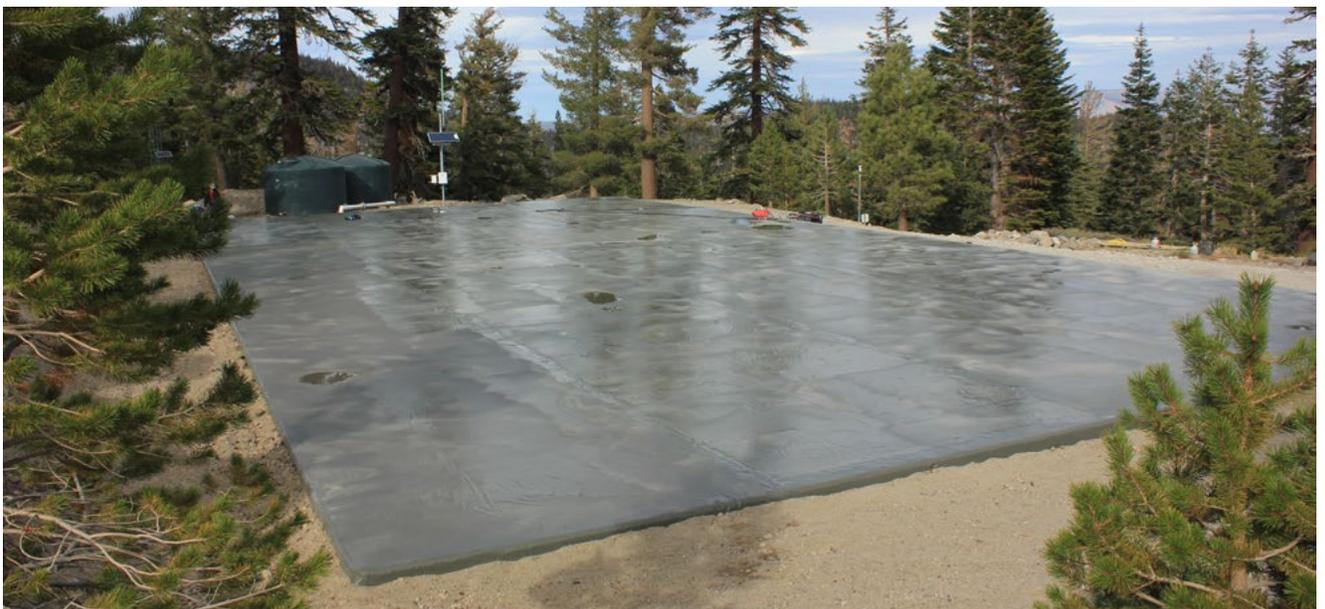
Finished Exterior Tank Top
