## POTABLE WATER

### MARKET SYSTEM PROJECT

Potable Water : Water Tank Coating Application  
 AquaVers® 405 Elastomeric Pure Polyurea  
 5 Million Gallon Water Tank Coating  
 City of Signal Hill-Signal Hill, California  
 KC Industries-Kent Hylton-Simi Valley, California

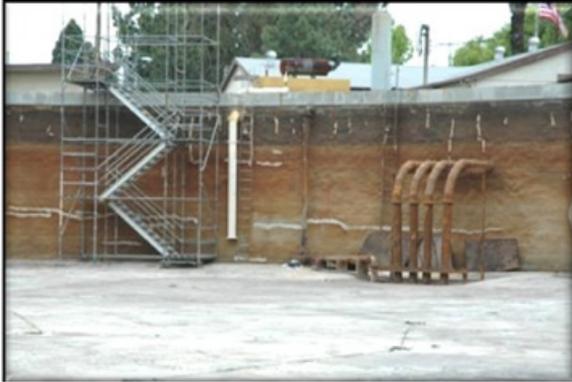
*Existing Tank*

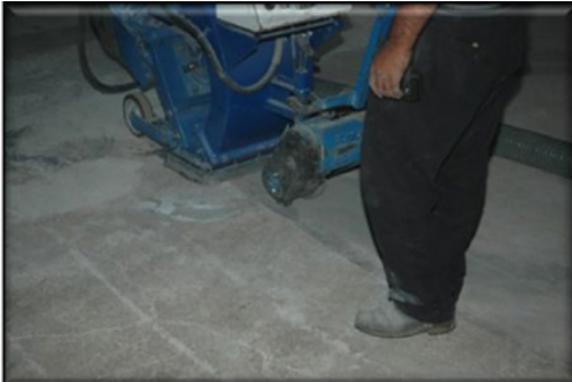
*Shot Blasting  
Surface Preparation*

Surface adhesion tests were performed in advance of the coating application to determine the type and degree of surface preparation required. The Sand Basin and main tank walls were prepared using a 3,500 psi high pressure water blast machine. The main tank floor was prepared using a shot blast machine, and any steel structure to be coated was prepared using dry abrasive blast. Large cracks and

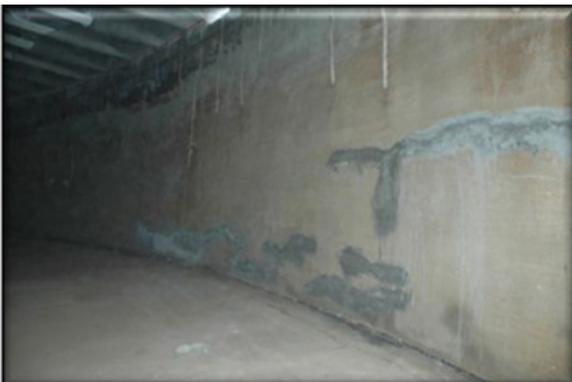
*Cracks Repaired*

spalls were repaired with Five Star Structural Concrete. Expansion joints were spanned using a four inch cloth backed butyl tape.

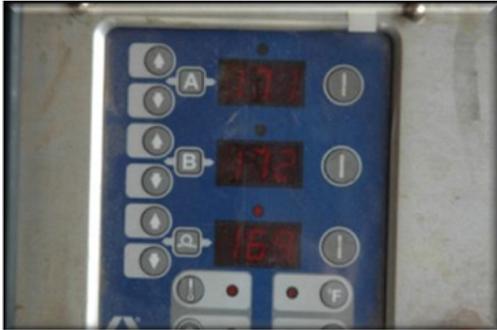
Because of the concrete surface profile, surface cracks and generally irregular surface, the coating specification was designed with an average minimum coating thickness of 80 mils. This allowed continuous coating coverage even on the rougher and more irregular portions of the concrete substrate. Basic requirements for system compliance is 60 mils, but many times surface considerations require more material for proper smoothing of surfaces.

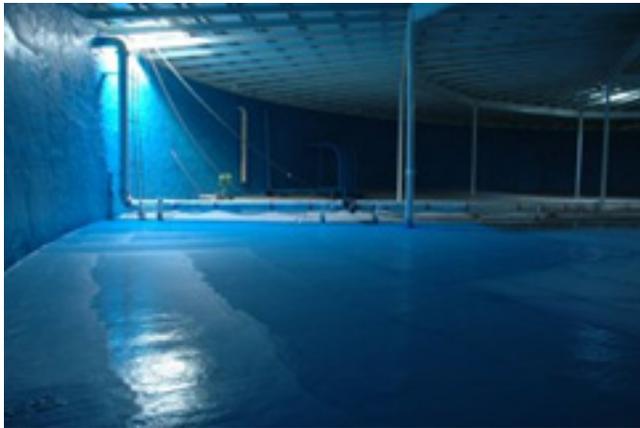
The condition of the existing tanks was such that repairs and follow-on tank coating was closely monitored for adhesion values. First pulls in each locale were undertaken within hours of coating installation and then attachment of the testing dollies. A delay of 12 to 24 hours was allowed to pass prior to the remaining pull tests.

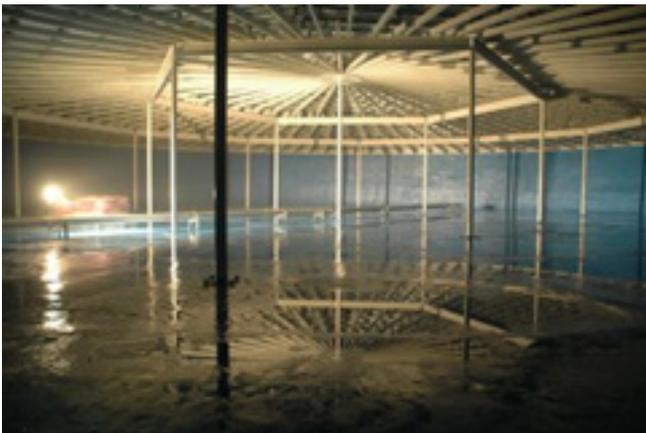
Subsequent to adhesion testing, test areas were re-prepped and polyurea coating was applied. If adhesion pulls had taken place after installation of completed spraying, this would have proven an additional step, thus testing was undertaken while spray operations were on-going in other tank locations.
