CONCRETE RESTORATION

Concrete Restoration / Rehabilitation

Bill Graham Civic Auditorium, San Francisco, California

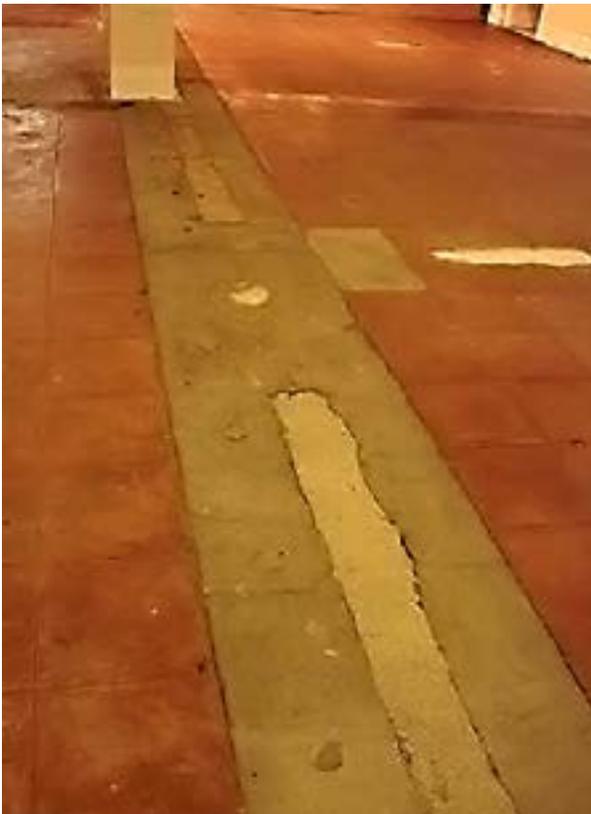
Some initial patchwork

substrate. It was found to be quite old and dingy due to the adhesive/glue used to secure the worn, deteriorated, and dirty carpet to the 4" concrete slab. After further inspection it was discovered that the glue contained asbestos which needed to be removed before any work commenced. A water jetting process was employed to remove the asbestos. The result of this process left the concrete with a textured finish. The resulting texture exposed how bad the condition of the concrete actually was.

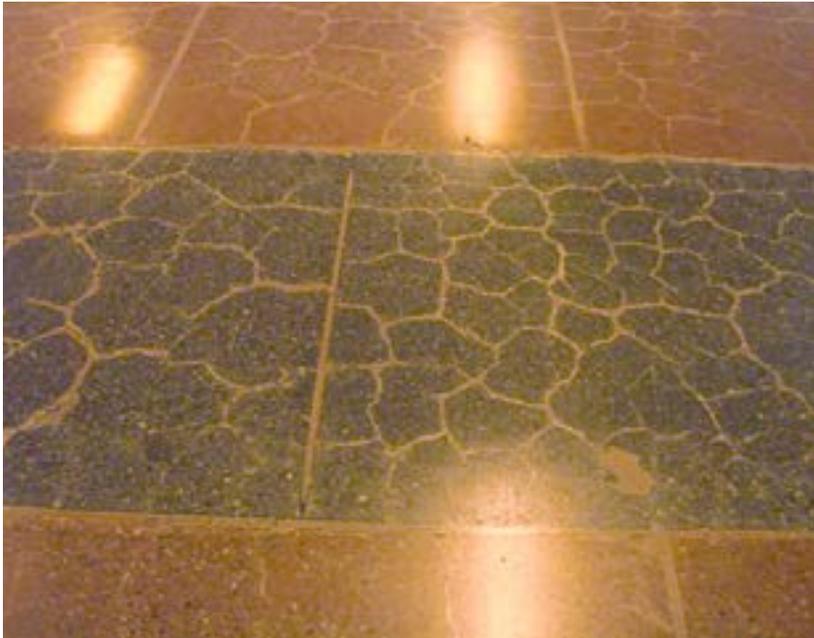
The existing concrete had a "shattered" look to it. A possible reason for this was its geographic location as well as being on the 2nd floor of a building on the west coast. It was even debated whether or not

the floor could be salvaged due to the earthquake and seismic activity that may have occurred. However, once the complete finishing process was over, the “shattered” appearance provided a decorative look that definitely added some appeal. Given the variations of concrete showing its age, as well as the miscellaneous repairs that had been done over the years, it was possible to see the history of all the concrete had been through while keeping its overall character. Certain areas had to have 1-3” depth repairs made with a rapid-set bag materials.
