CONCRETE REPAIR

Concrete Repair / Rehabilitation
 Quick Mender® X.O. Repair Polymer
 Cold Storage Freezer, Dallas, TX
 Private
 Exposed Floors, Garland, TX

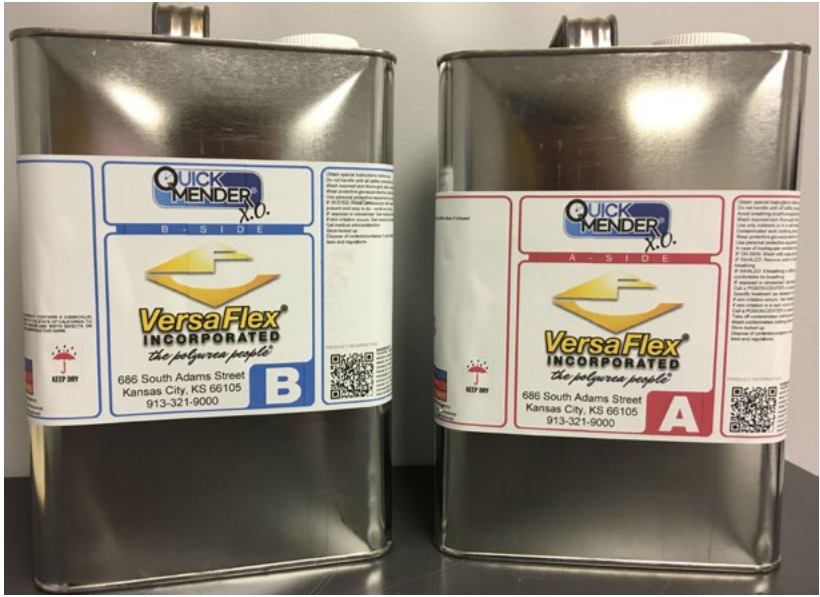
Food processing facilities rely heavily on the concrete floors for the most basic of their business needs, forklift traffic. The concrete floors in cold storage facilities take an even greater beating due to the -20+ degree temperatures they endure. Crumbling concrete infrastructure is a serious issue in these facilities as it poses a safety hazard, as well as potential lost revenue as a result of lengthy repairs.

In a cold storage facility in Dallas, TX, this scenario became a reality. Two large crater-like holes were beginning to form and the concrete was crumbling badly. The crater-like holes had grown to sizes of about 5 ft. by 3 ft. and 2 ft. by 3 ft. at a depth of about 5 inches each, meaning it was no longer safe to drive forklifts in the area, causing traffic to be re-routed to other areas of the warehouse. The facility owner decided to get it repaired quickly, and called Steve Cassity of Exposed Floors of Garland, TX to help.
