# civil + structural ENGINEER

## REHABBING AGING CONCRETE WASTEWATER INFRASTRUCTURE

ADVANCED POLYUREA COATINGS AND LINERS PROVIDE STRONG, FLEXIBLE WATERPROOFING TO BRIDGE CRACKS AND PROTECT AGAINST FUTURE CRACKING AND DETERIORATION.

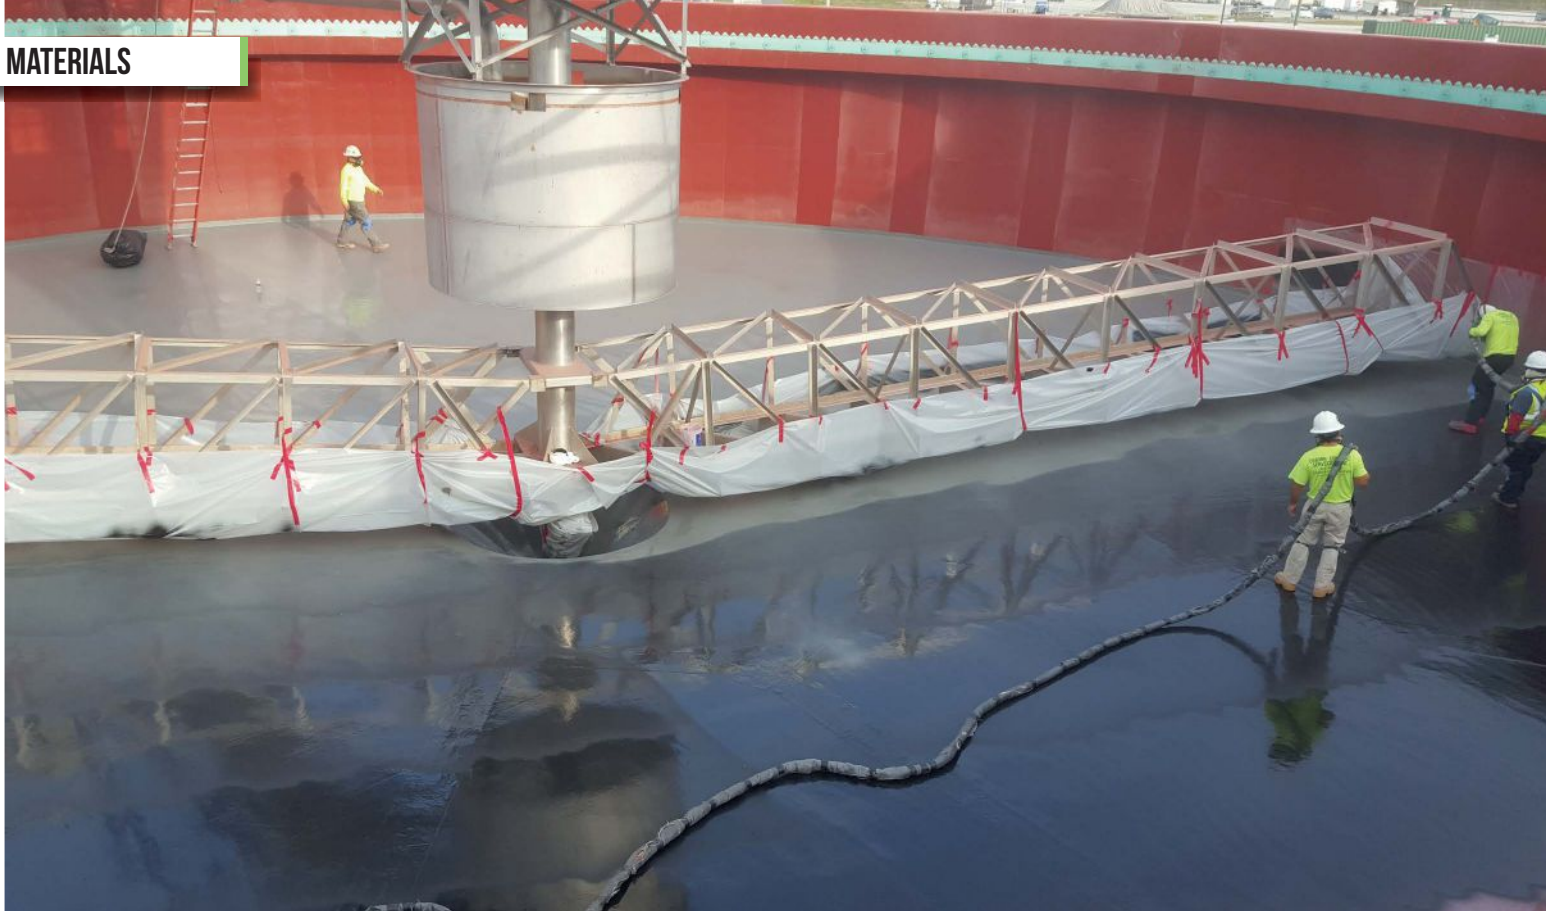
Spray-applied polyurea coatings create a seamless, waterproof, durable protective liner that stops leaks and strengthens the integrity of the entire structure.

The spray-applied coating creates a seamless, waterproof, durable protective liner that stops leaks and strengthens the integrity of the entire structure. It exhibits superior physical properties such as elongation up to 400 percent, crack bridging, hardness, and tensile strength to create a robust industrial liner that protects, strengthens, and waterproofs concrete wastewater infrastructure.
