MARKET SYSTEM PROJECT

Floor Coatings : Concrete w/ rubber mat underlay

Renovation of Exhibit and Habitat areas, Elephants

Aalborg Zoo, Aalborg, Denmark

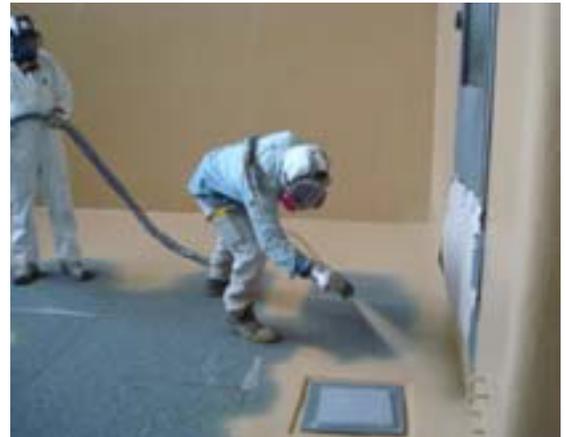
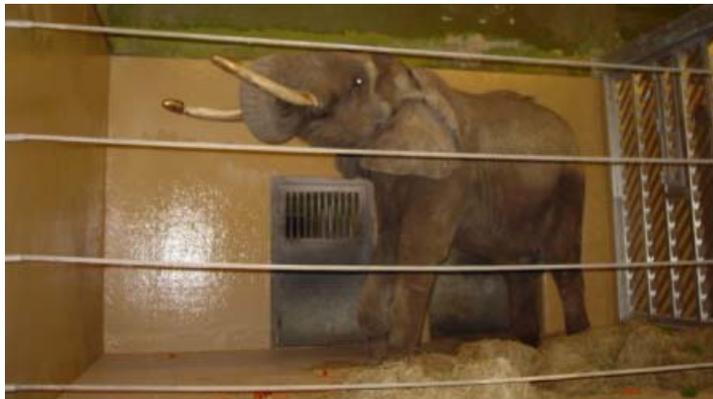
After preparation, the walls were primed with an epoxy system incorporating sand to fill voids and bugholes. The sand also provided a textured surface

for improved adhesion of the polyurea system. An epoxy system was then used to adhere the 1.5cm (0.6 inch) ground rubber mats to the floor for the soft feel. VF 380 was applied to the walls at a thickness of about 2.0 mm (80 mils), while approximately 4.0 mm (160 mils)

Prior to the installation of the system, the concrete stall areas were cleaned / prepared as per SSPC-SP13. This involved the use of high-pressure water cleaning to remove existing paint and debris, providing for a CSP3 to CSP 4 profile.

of the VF 380 was applied to the installed rubber mats. This provided for the continuous elastomer membrane with excellent adhesion to the rubber mats. 24 hours after installation of the system, the elephants were placed in the cells for feeding with no damage to the system.

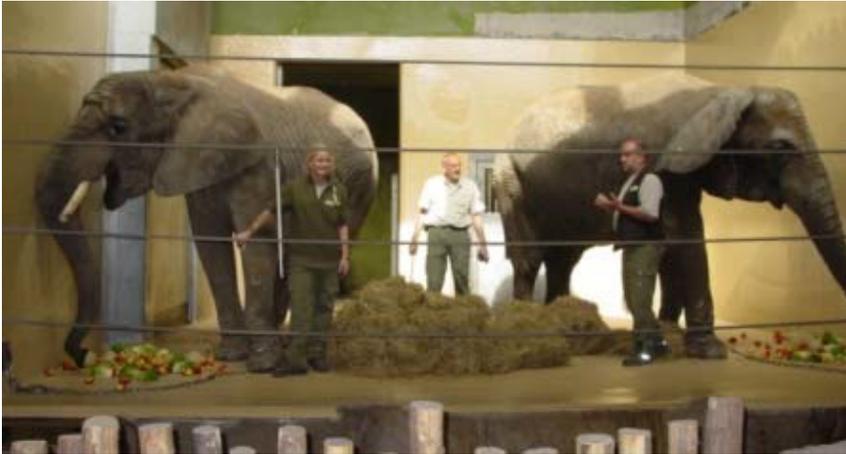
A view of happy elephants at feeding time - they can't quit talking about the new protective coating.
