MARKET SYSTEM PROJECT

Potable Water : Drinking Water Reservoir
 AquaVers® 405 Potable Water Approved Polyurea
 1 Million Gallon Drinking Water Reservoir : Protective Lining
 City of Blaine, Washington
 Vector Construction

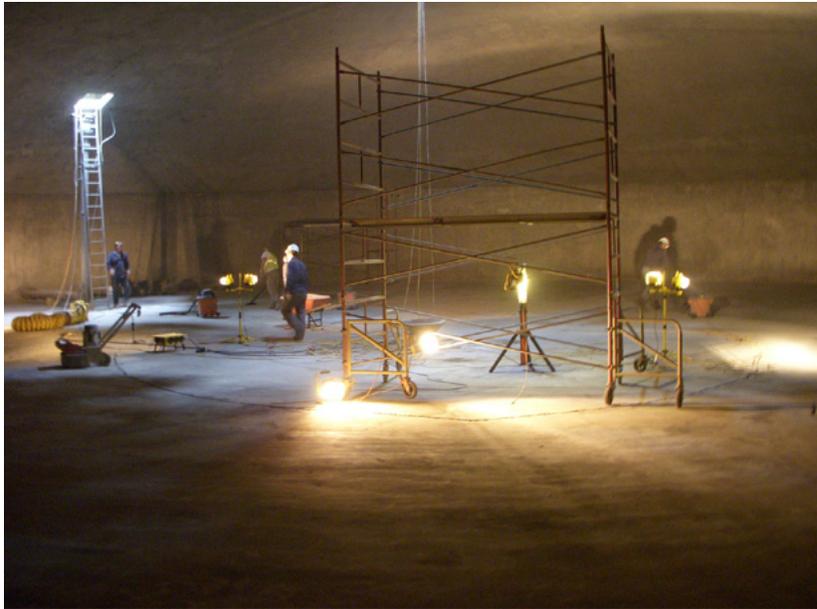
Together with Tiger Construction LTD, Vector Construction recently conducted a job to remove an old tar tank liner in a one million gallon water tank for the city of Blaine, Washington. The specification called for the installation of a new NSF/61 polyurea lining system that was eventually applied by Vector Construction Inc., out of Port Townsend, Washington.

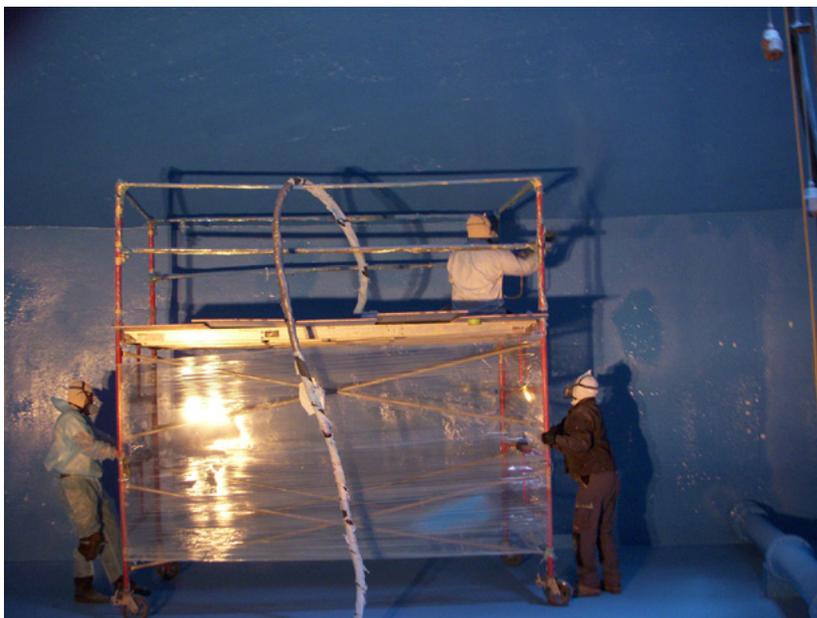
The existing 22,000 square foot tank had old and deteriorated concrete. The jobsite was riddled with unusual factors that made the job more difficult. All the equipment and supplies had to be lowered through a 30"x30" access hole or a 36" round vent at the top of the dome.

In addition to the challenges listed above, the tank's concrete roof leaked every time it rained and ground water was leaking in at the cold joints.

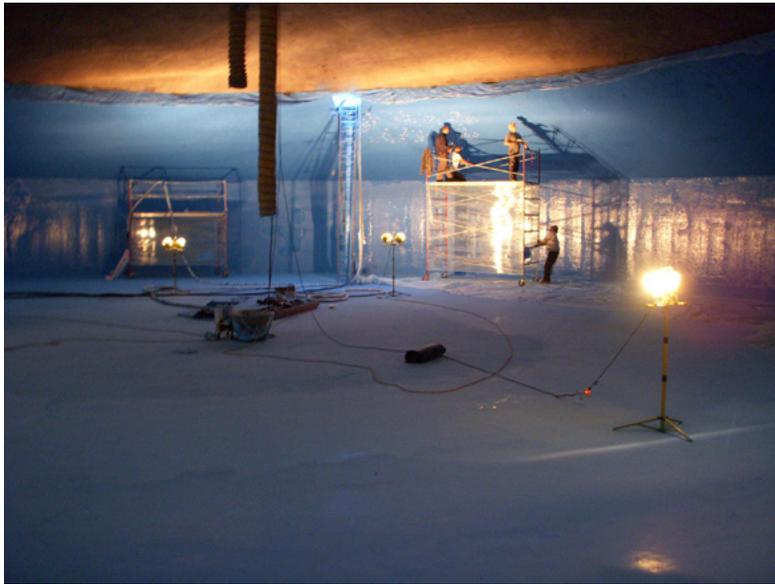
In order to accomplish the job, the crews had to remove 20 cubic yards of an old tar liner, old caulking, and creosote soaked

oakum from large cracks in the floor. The tank was then blasted to the appropriate surface profile, pressure washed and vacuum cleaned.

Propane heaters, large fans and dehumidifiers were used to dry out the tank and regulate the temperature and humidity. A large tarp was laid over the tank top to control rainwater intrusion during the application.

Zypex was used for leaks and a latex fortified patching compound was utilized on the larger spalls. The floor

cracks were prepped, primed with Quick Mender and filled with a joint filler to complete the repair.

The surfaces to be coated were sprayed and backrolled with AquaVers 20 Primer. The portion of the dome above the water line that was not scheduled for polyurea, was also sprayed with a rust preventive primer.

When the time came for the polyurea lining, three Gusmer/Graco H-20/35's were used to apply AquaVers 405 to a final dry film thickness (DFT) of 90 mils. The spray application was continuous to insure a seamless liner.
