## CONCRETE WATERPROOFING

### MARKET SYSTEM PROJECT

Concrete Roof Deck Rehabilitation and Coating

Cargill Agriculture, Elm Creek Farm Service Center, Manitoba, CA

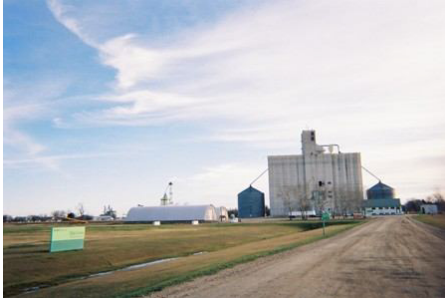
The Cargill facility is primarily a large grain elevator for seed and fertilizer. Constructed of concrete, the roof area has cracked and leaks, causing spoilage of the grain. Tar / asphalt has been used over the years, but continues to crack and require repairs. The polyurea coating technology was chosen due to the high elongation, toughness and ability to apply in the cooler weather.
