WATERPROOFING

MARKET SYSTEM PROJECT

Waterproofing : Roofing
 SL/45 Joint Filler, FSS 50DM* Elastomeric Polyurea
 Roofing Application : Concrete / Polyurethane Foam Substrates
 Good Sheperd Church
 Structural Repairs (M) Sdn Bhd

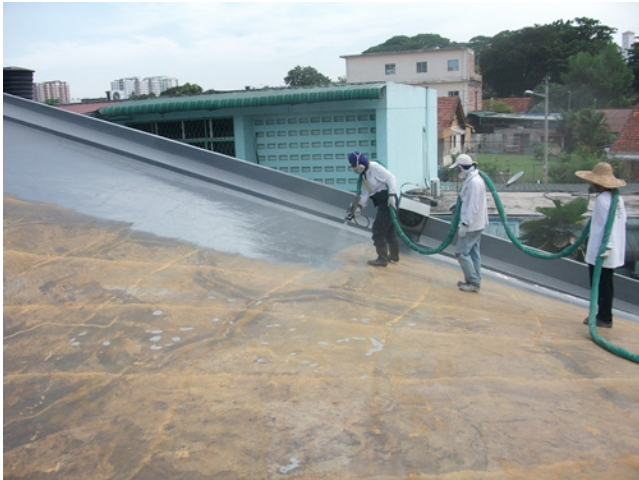
There were two major problems at the Good Shepherd Church prior to the 2010 installation of a new roof coating system. One of the problems was a leaking concrete roof deck, and the other was the heat in the tropical weather, which made the interior unbearably hot during the afternoons.

First, the crack lines were filled with VersaFlex SL/45 joint filler. On the concrete roof where heat insulation is not required, VersaFlex FSS 50DM was spray applied to the concrete substrate which had been primed using VF30.

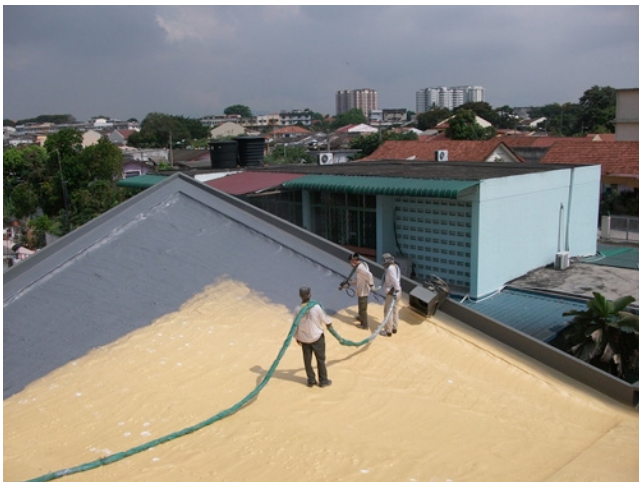
On the roof where insulation from the tropical heat was a necessity, FSS 50DM was sprayed directly over polyurethane foam. The foam provides the heat insulation, while the FSS 50DM acts as the waterproofing coating to prevent water or moisture damage to the foam substrate.
