Waterproofing : Animal Habitats & Water Features

Grizzly Bear Habitat : Water Basins and Decorative Rock Formations

North Carolina Zoological Park, Asheville, NC

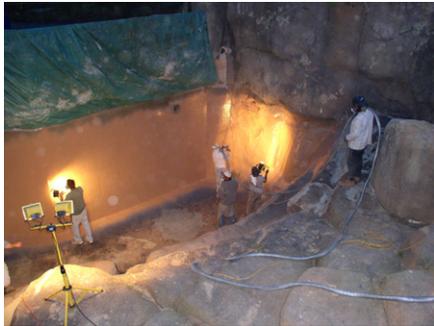
The North Carolina Zoological Park, in Asheville, once again called upon Safe Step to effect repairs at the massive facility. This time the grizzly enclosure was in need of work, since over the years the large swimming tank had developed leaks and the grizzlies had begun to destroy the gunite rocks and slabs. Just like any creature with too much time on their paws, the redoubtable grizzlies pick at stuff until they demolish it.

Safe Step repaired the tank with epoxy injection, and then a 60 mil polyurea coating was applied to the tank and all the other watercourses in the compound. They reworked some of rocks and slabs and coated those features with either brown or gray aromatic polyurea, to blend into the overall color scheme. The mocha and light gray 45DC has much higher color stability properties than older formulations due to upgraded amines and pigments.
