SECONDARY CONTAINMENT

Oil Containment Liner

Gas & Oil Transfer Facility

Mid-America Coating Systems

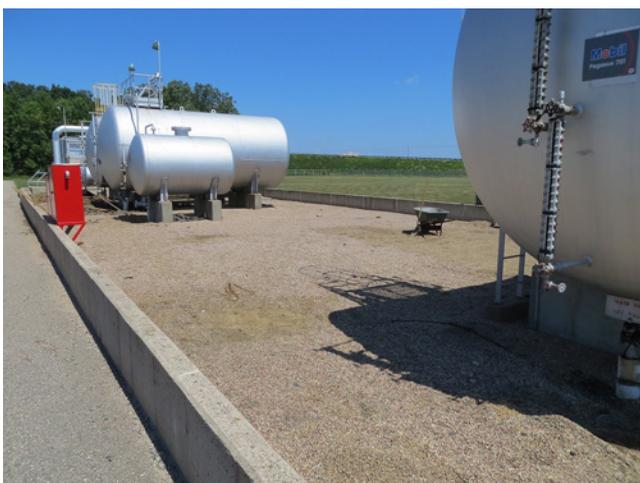
When the Regional Manager for a gas and oil transfer facility needed to upgrade their containment dikes he knew he wanted to use a polyurea liner. He had just recently heard about polyurea at a meeting he attended but had no idea who to contact. After an extensive search, he determined that Mid-America Coating Systems was the right choice. Not only did they have the ability to install the liners but also had a vast amount of experience with all types of industrial and commercial coating applications.

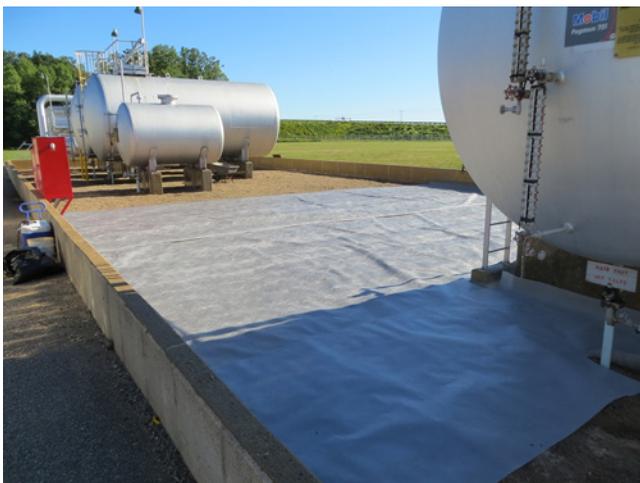
The project consisted of the complete removal of the existing 6 to 12 inches of gravel ranging from pea size gravel in one containment area to fist size stone in some others. Because of the potential volatility of these facilities, all preparations, including the removal of the gravel, had to be done by hand using shovels and wheelbarrows. All concrete walls and tank bases had to be pressure washed clean and any damaged areas were repaired. All concrete surfaces were primed using VersaFlex VF-20 primer.

After leveling, the ground was covered by a 6 oz. geotextile fabric which extended 6 inches up on to the concrete walls and tank bases.

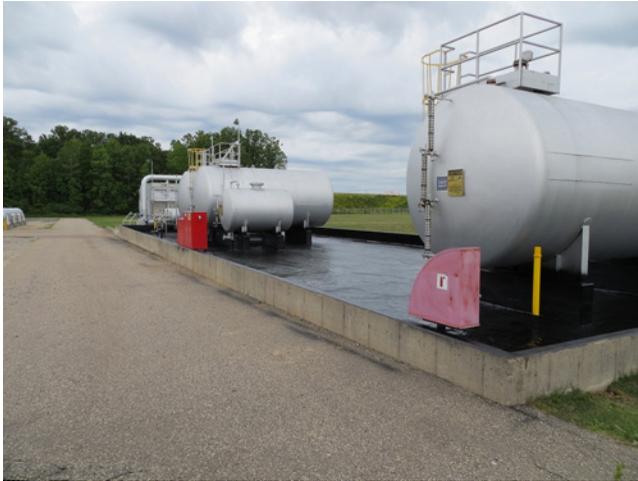
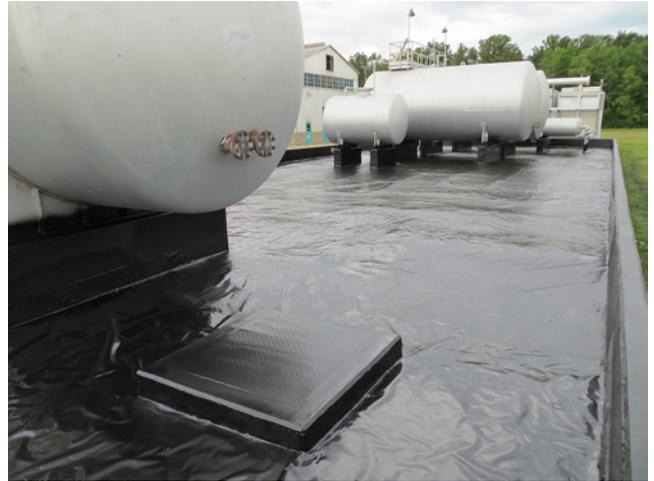
The geotextile was then covered by a minimum of 80 mils of VersaFlex VF380. VF380 was the material of choice because of its toughness, flexibility and its slower reacting time which enables the polyurea to penetrate the surface of the concrete and into the fabric before setting creating a complete bond between all surfaces. To complete the project, a series of slip-resistant walkways were installed using the VF380 and embedding ceramic granules into the wet coating.

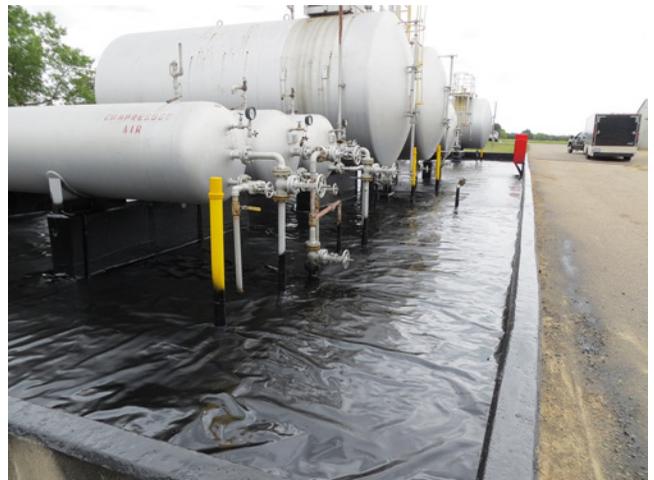
At completion, a water test was done to make sure the liner was performing to specifications and did not leak. As expected, the liner passed with flying colors.
