WATERPROOFING

Waterproofing : Condominium Parking Structure
 FSS45DC Aromatic Elastomeric Spray Polyurea
 Waterproofing & Vehicular Traffic
 Homeowners Association, Sutton Park, Rochester, New York
 Rick Donoghue

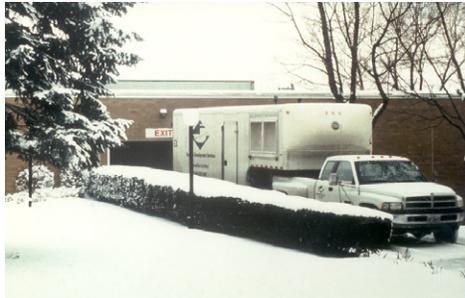
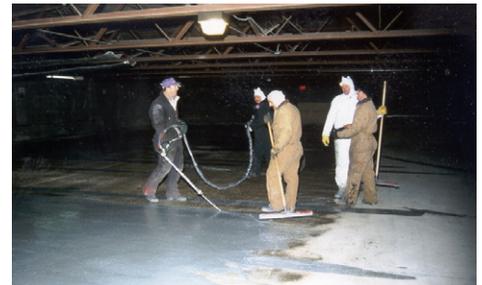
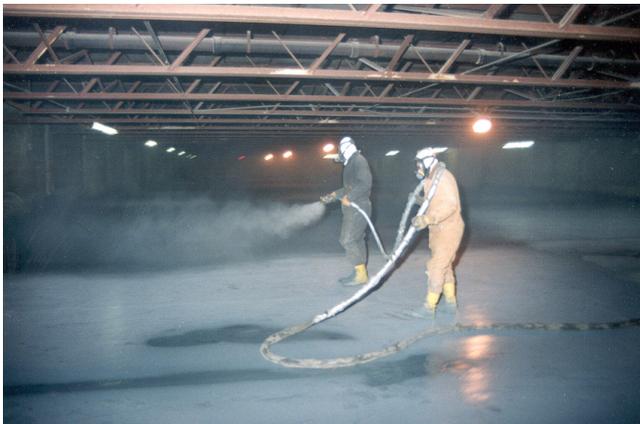
Major repairs and coating of this 21,000 S.F. parking deck located in up state N.Y. presented a serious problem for the new property management company, The Cabot Group. Years of prior neglect had taken its toll on this upper level deck. Freezing temperatures, water, and road salt had spalled the entire surface area, exposing the aggregate. In addition, all the control joint caulking had failed and the deck had

developed a number of major random cracks. An evaluation report from a local engineering firm suggested immediate repairs, leveling areas where ponding water was a problem, and then installing an elastomeric membrane coating to prevent further moisture migration through the deck surface.

The Parking Deck System coating cures in minutes instead of hours. The Parking Deck System was installed with no heat at an average temperature of 19° F. The product was applied at approximately 75 mills with no aggregate sprayed into the top coat. A unique process called stippling was used to create a non-skid surface. Hairline cracks were easily bridged with this flexible membrane, locking out further moisture migration. The deck was striped and opened to traffic only 18 hours after the final top coat had been applied.
