MARKET SYSTEM PROJECT

Water & Wastewater: Anaerobic Digester Tanks
 VF-380™ Elastomeric Polyurea over Medium Density Spray Foam
 Anaerobic Digester Tank Lid Protection
 Burlington Wastewater Treatment Plant, Burlington, WA
 Cascade Industries N.W., Bothell, Washington, USA

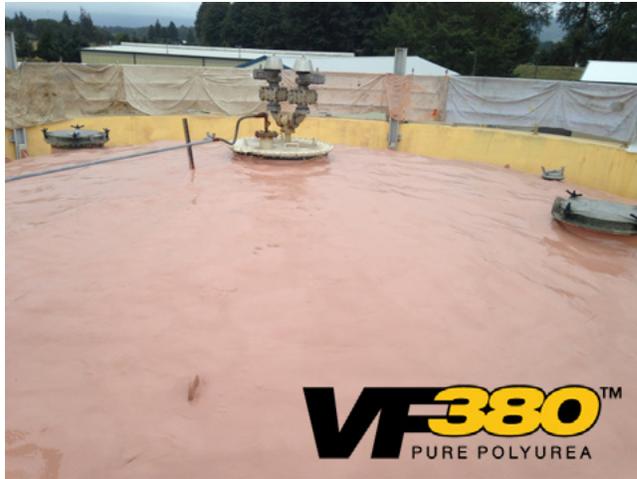
The the yellow coating around the edge is the VersaFlex FSS 45DC™ polyurea sprayed 18 years ago on the interior walls of the tanks, and is still performing well.

Interestingly enough, while on the job the team discovered that that digester tank walls were also sprayed with polyurea almost 18 years prior. The polyurea was also from VersaFlex -- FSS 45DC™, their flagship protective coating for concrete. The polyurea was noted to be performing extremely well after 18 years in service.

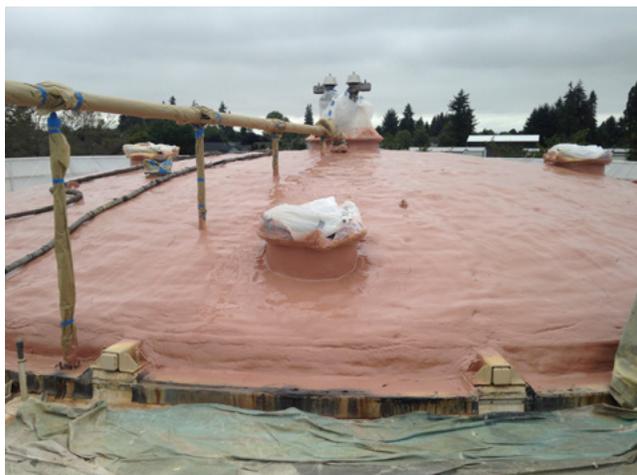
Digester lid is restored to better than new condition with VersaFlex VF-380™ pure polyurea topcoated over medium density, closed cell spray foam insulation.

The project was roughly 3200 sq ft in size and consisted of a one (1) inch thick base of spray polyurethane foam insulation topcoated with pure polyurea (VF-380™), one whose physical characteristics are a perfect for spray foam. The polyurea topcoat was applied at an average thickness of 80-90 mils.

The VF-380™ system used as the topcoat on this project is especially well-suited for use in tandem with spray foam. The VF-380™ is a very low-shrinkage polyurea and therefore has no adverse effects over the spray foam when applied properly.
