# WATERPROOFING SYSTEMS

## MARKET SYSTEM PROJECT

Waterproofing / Rehabilitation  
 FSS 45DC™ Pure Polyurea / VF 20™ Primer / HM 45™ Hand Mix  
 Texas A&M Concrete Cooling Tower Basin Waterproofing  
 Texas A & M University, Utilities & Energy Services  
 Southwest Coating & Lining, Houston, Texas

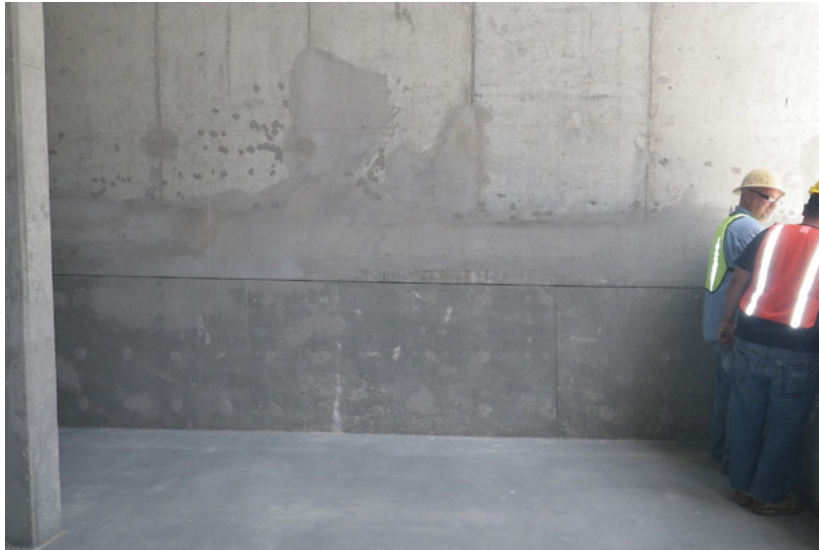
Termination Joint (saw cut)

Surface preparation of the new formed concrete basin was completed by abrasive blasting using #5 quartz media, following SSPC-SP 13. This produced a Concrete Surface Profile (CSP) of 3, as per ICRI No. 310.2R-2013. A 1/4" (6.4 mm) diamond blade was then used to cut a termination groove / joint around the complete interior perimeter, and around the interior columns, above the water line within the cooling tower pit. The area was then vacuumed to remove all dust and debris.

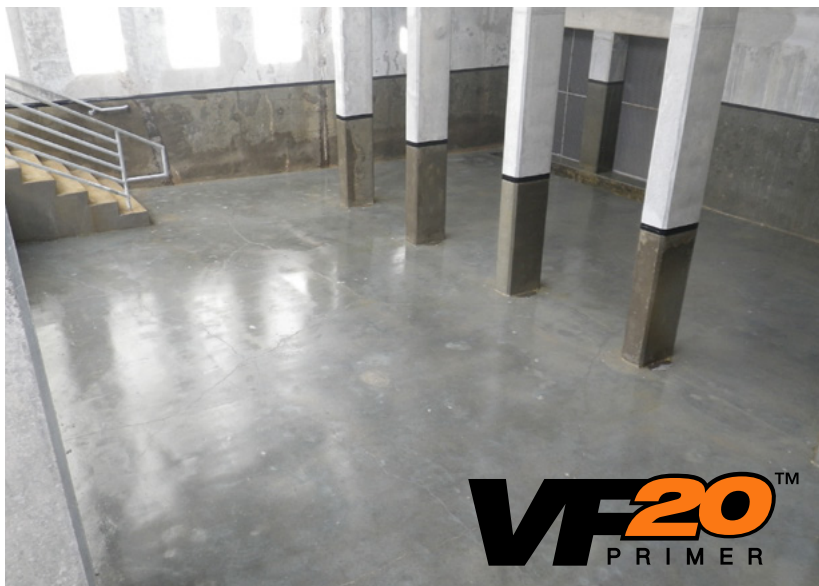
VF 20 Urethane Primer applied to concrete basin / columns

The prepared concrete surface was then primed using VersaFlex VF 20 urethane primer. This is a specialty designed 100% solids penetrating primer for concrete

surfaces that also reduces moisture vapor emission in concrete. The primer was applied at 8 – 10 mils (200 – 250 µm) using rollers. Minor bugholes were pre-filled using a moisture cured urethane sealant. Minor infiltration of water at the stair area was plugged using hydraulic cement, prior to priming.

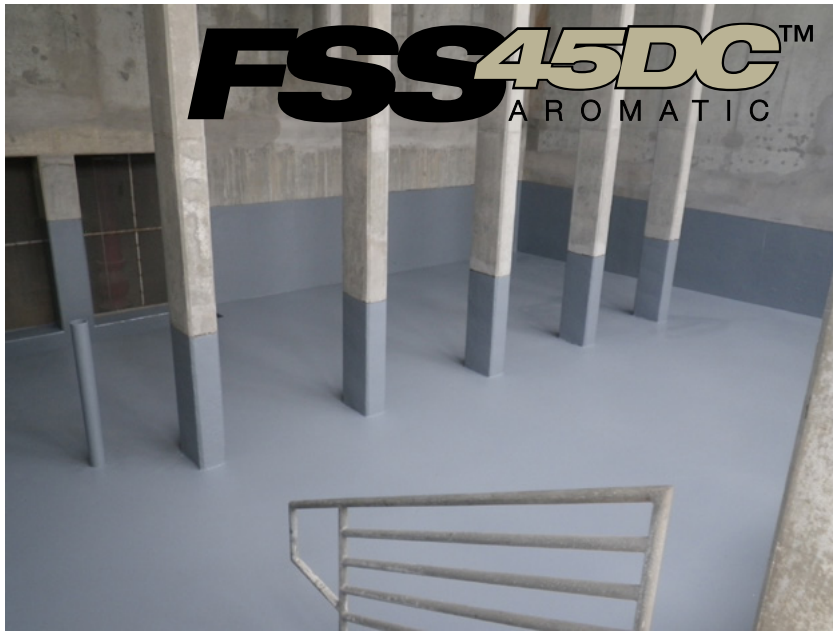
View of Finished Interior

using a GRACO Reactor H-40 proportioning unit, fitted with a GRACO FUSION AP impingement mix spray gun. The FSS 45DC was applied at a minimum average 80 mils (2 mm), confirmed using a Positector Advanced gage, fitted with a Positector 200 D probe, as per ASTM D 6132, and SSPC-PA 9 procedures. Minor spot repairs were touched up using the VersaFlex HM/45 polyurea repair system.

After priming, the cooling tower basin was lined using the VersaFlex FSS 45DC aromatic polyurea system. Application was completed

The cooling tower project lining work was completed within 1 week.
