## FLOOR COATINGS

### MARKET SYSTEM PROJECT

Decorative & Functional Concrete Coatings  
 Aliphatic Clearcoat™, Quick Mender® Repair Polymer  
 The Other Place (Restaurant), Shawnee, Kansas  
 Private  
 Integrated Floor Systems, Kansas City

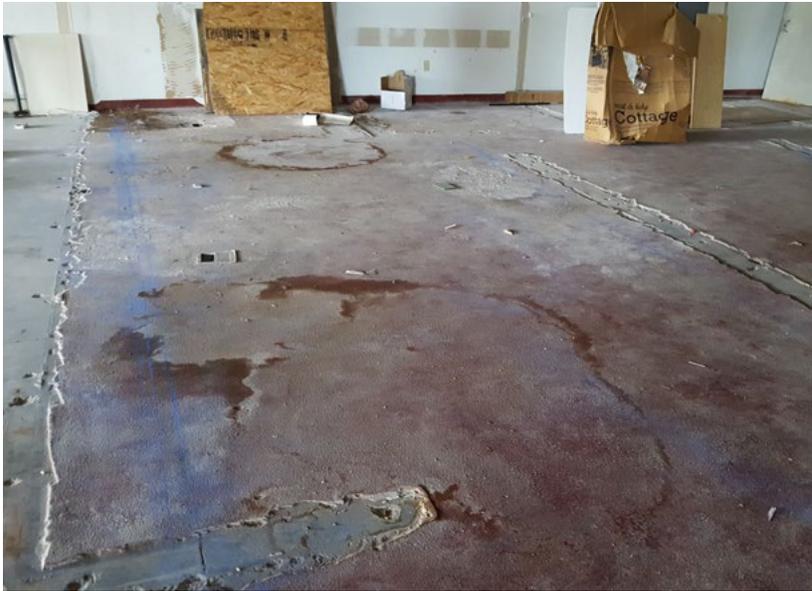
*Initial view of the space with walls/fixtures removed*

All walls and fixtures were removed from the space before the remodel job began, and this put added pressure on the flooring contractor to ensure a quick return to service was possible in order for other trades (carpenters, electricians, painters, etc.) to be scheduled to complete their subsequent work.

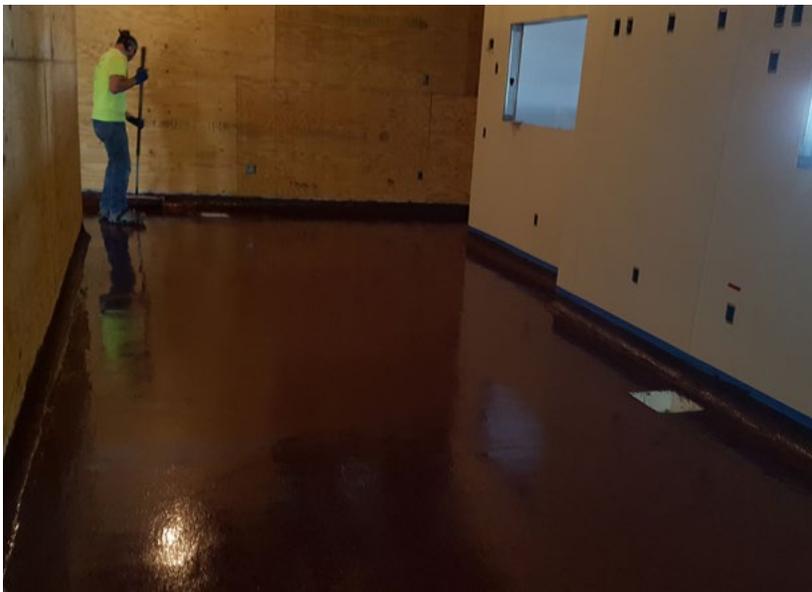
*Epoxy coating install, kitchen area*

solids epoxy was installed as a basecoat, with a quartz sand broadcast to give it a non-slip surface. Then VersaFlex Aliphatic Clearcoat™ was used as a topcoat, with pigment added to color match with the theme of the restaurant.

The contractor suggested Aliphatic Clearcoat “because its quick cure time allowed other trades to get back on the floor and work, and it has a better abrasion and chemical resistance than typical epoxy.” The quick cure time of the Aliphatic Clearcoat allowed construction time schedules to proceed unimpeded -- in this case “the ACC could be put down the final part of the day, and the very next morning it was cured enough to take light construction traffic, saving money and time for all involved.”

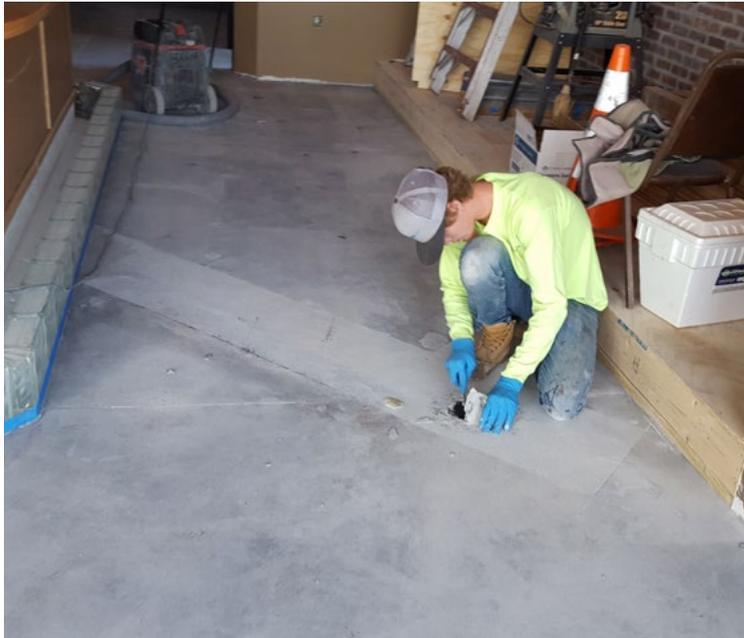
*After Quick Mender® LO. application*

Initial repairs to the 1500 sq. ft. kitchen area were performed using VersaFlex Quick Mender® L.O. (Low Odor) Repair Polymer, used to fill cracks, spalls, and defects in the existing floor. A typical 100%

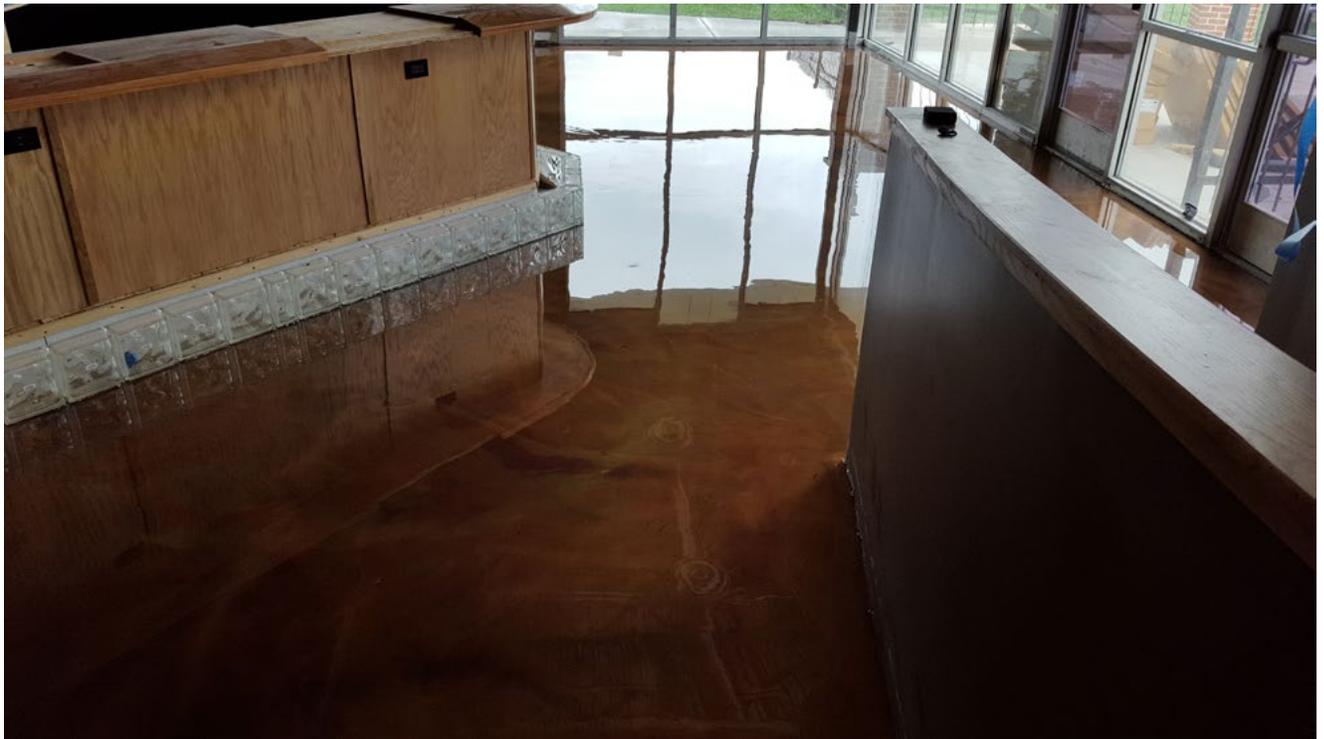
*Bar / Restaurant Area*

For the 2000 sq. ft. area surrounding the bar, a similar approach was taken to achieve the “cool” look the restaurant desired.

Initial concrete repairs were performed using Quick Mender® L.O., with diamond pad grinding as surface prep for the subsequent coatings.

A typical epoxy basecoat (black), followed by a metallic epoxy coat to give some visual interest were applied and allowed to cure. Then a topcoat of VersaFlex Aliphatic Clearcoat™ (un-pigmented) was applied. This allowed the metallic epoxy coating to show through, and “added a ‘depth’ that other sacrificial clear coats such as 2 component water based products don’t have.” It also allowed for the quick return-to-service necessary for other trades to complete their work, and doesn’t have a lingering odor like traditional solvent-based polyurethanes.

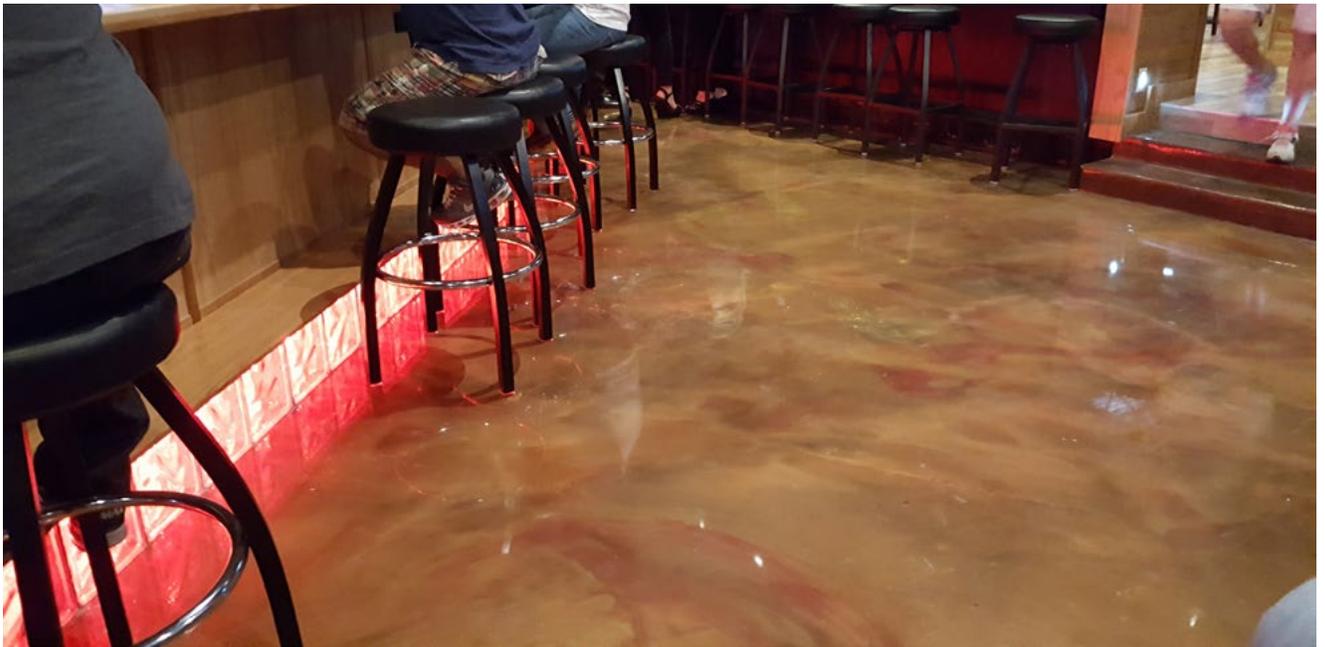
*Finished bar/restaurant area*

An important benefit is that ACC is highly UV-resistant; the restaurant has large windows letting in lots of sunlight, which could make other coatings become chalky or fail in other unappealing ways.

The job was completed on time, and allowed other trades to work efficiently. Upon attending the bar/restaurant open house, the owner spoke to the contractor about doing three other locations with the VersaFlex Aliphatic Clearcoat™ system, because he could already tell that it was far superior than the clear coats installed by another company, which didn’t have the “depth” and were beginning to fail.
