VersaFlex

Speed Bump – Parking Deck

Quick Mender XO/SL 60 Joint Fill

October 2018

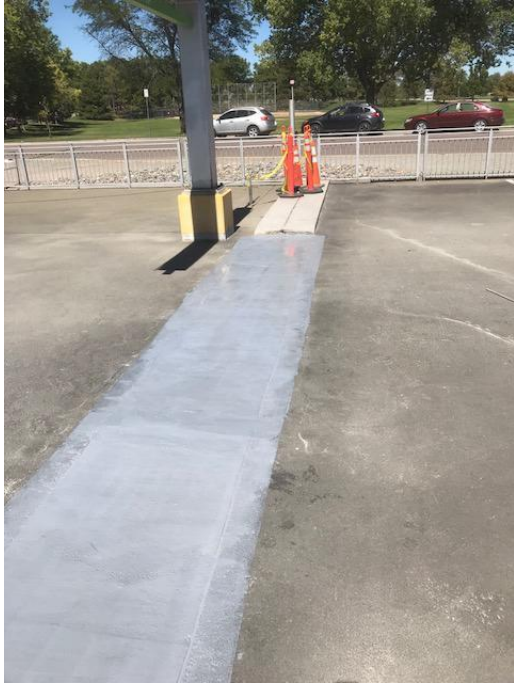
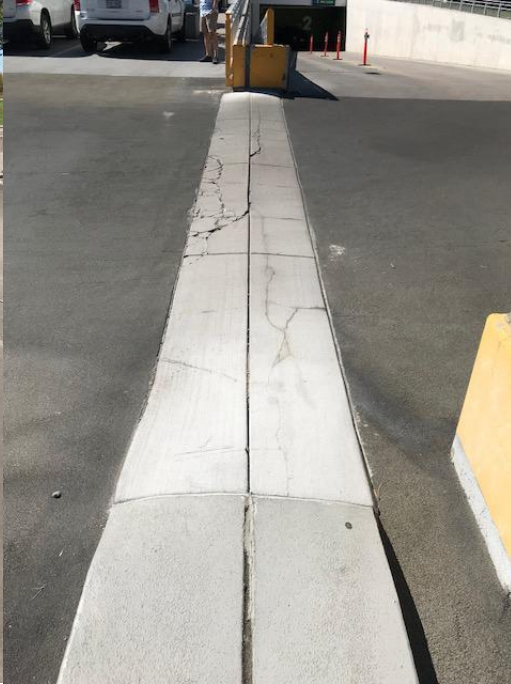
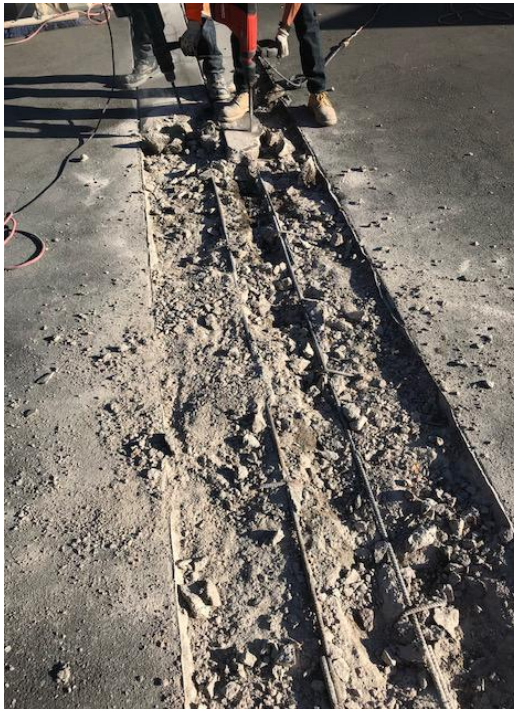
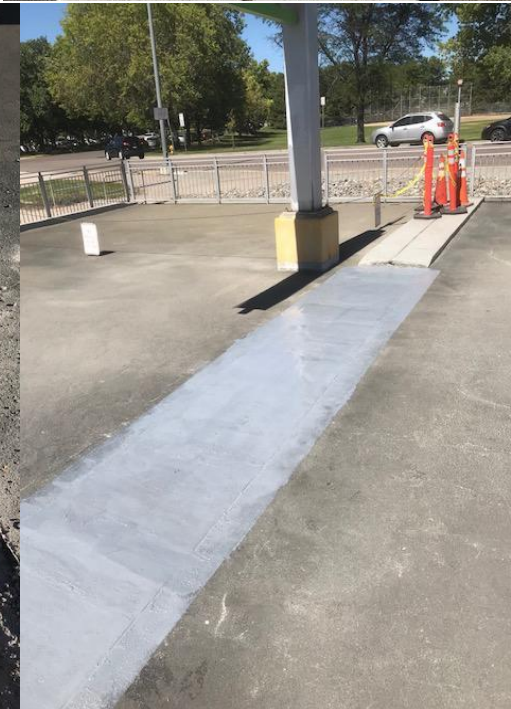
This was an excellent project application in Denver, CO for VersaFlex utilizing Quick Mender XO (urethane repair material) and SL60 exterior rated joint filler on the complete removal of 3.5” of a speed bump on a parking deck structure. An aggregate blend added to Quick Mender XO was used to fill in the removed area providing a slurry filled urethane-based mortar. SL60 joint filler along with bond-breaker design were installed along termination points to provide a flexible, durable and long-lasting repair to this heavy traffic parking structure. Quick Mender, the Swiss Army knife of concrete repair materials.
